The fire resistance performance of a partially insulated, single-acting single-leaf access door when tested generally in accordance with BS 476: Part 22: 1987, Clause 7.

185754

**Timloc Building
Products Limited**

10th November 2009

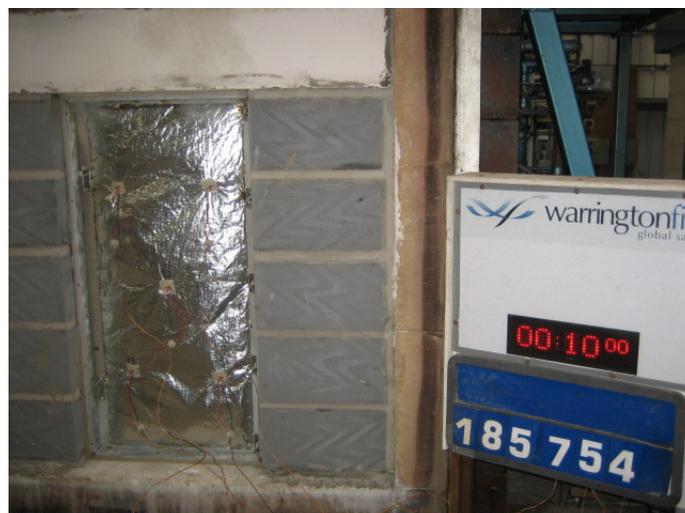
| Time | | All observations are from the unexposed face unless noted otherwise. |
|---|---|---|
| 11 | 00 | The outer layer of foil becomes detached from the left side of the head of the door leaf. The maximum temperature rise is exceeded from thermocouple number 10. Insulation failure is deemed to occur. |

The unexposed face of the specimen after 10 minutes of testing

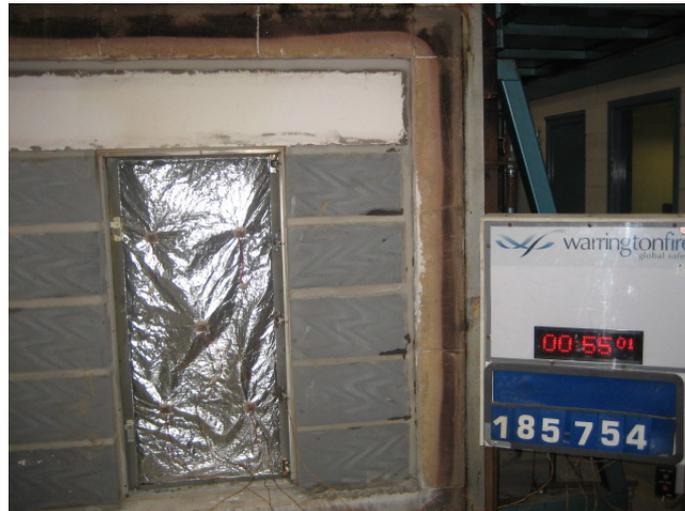
| Time | | All observations are from the unexposed face unless noted otherwise. |
|---|---|---|
| 22 | 00 | The top 100 mm of the leading edge of the door leaf begins to glow a dull red in colour. |

The unexposed face of the specimen after 55 minutes of testing

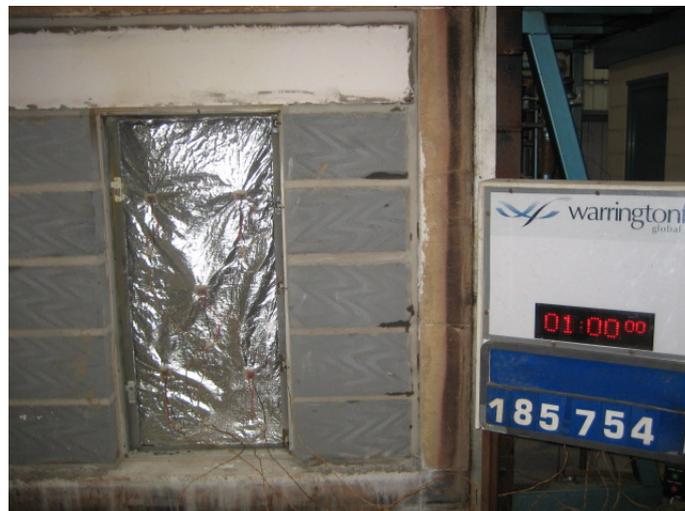
| Time | | All observations are from the unexposed face unless noted otherwise. |
|---|---|---|
| 60 | 00 | The doorset continues to satisfy the integrity criteria of the test. The test is discontinued. |

The unexposed face of the specimen after 60 minutes of testing

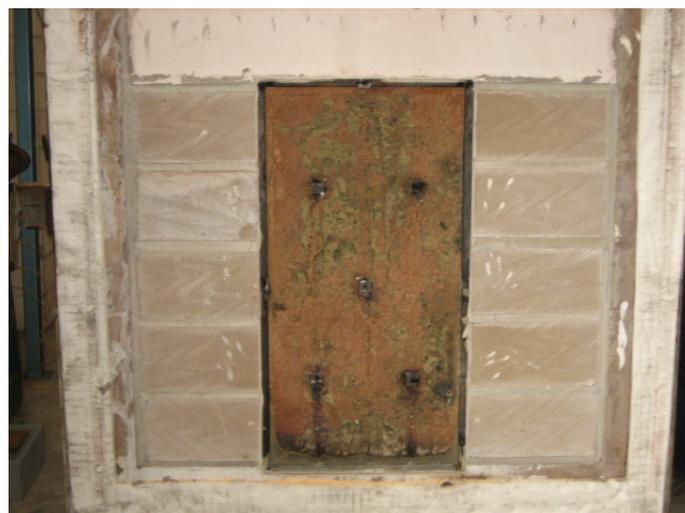
The exposed face of the specimen immediately after testing
