Fire Resistance Test Utilising
The General Principles of
BS 476: Part 22: 1987 on Two
Specimens of Access Hatch

309752/A

**Timloc Building Products
Limited**

Date: 20th September 2011

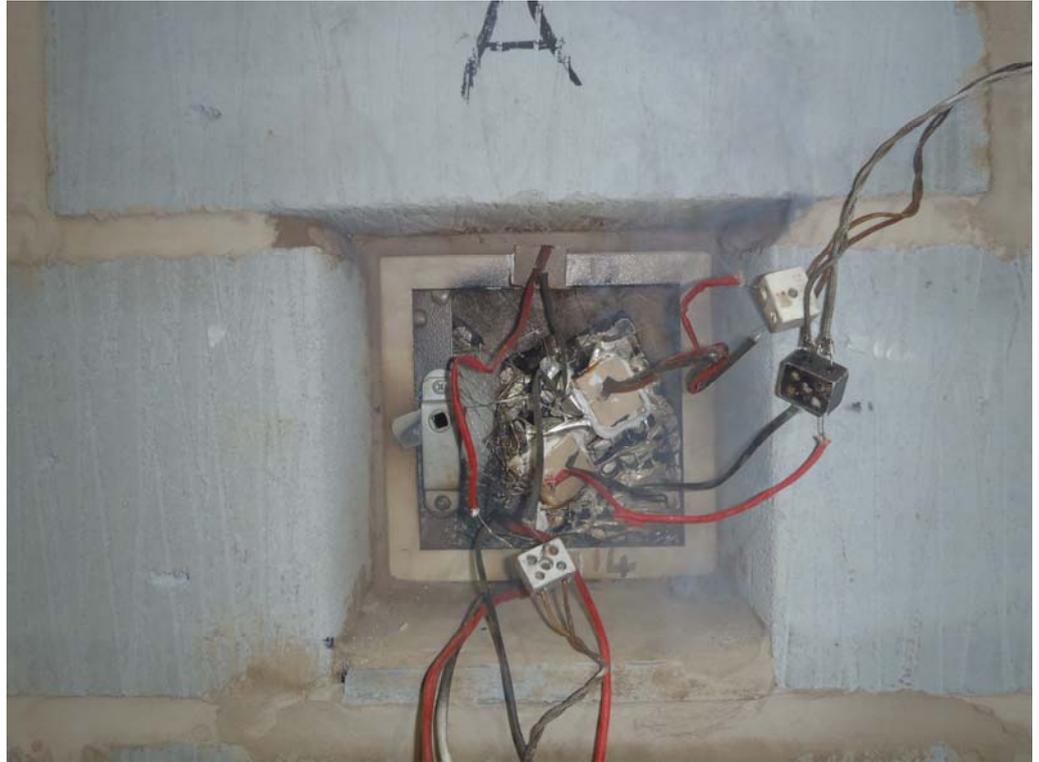
The unexposed
face of Specimen
A after a test
duration of 10
minutes

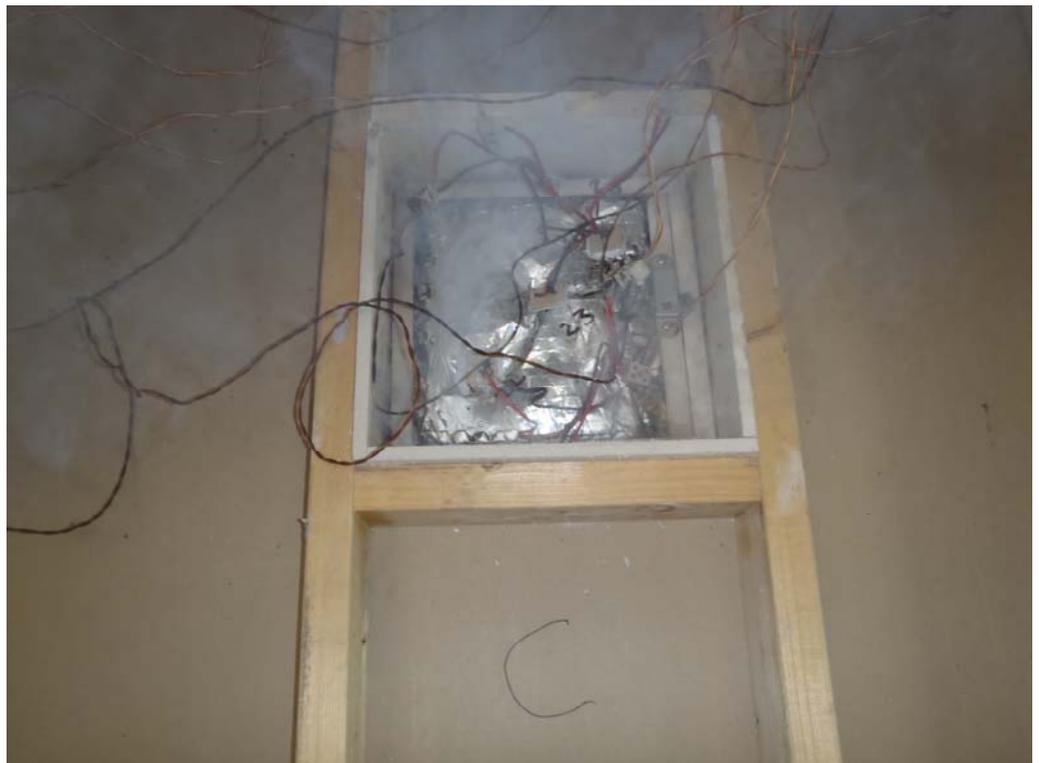
The unexposed
face of Specimen
C after a test
duration of 10
minutes

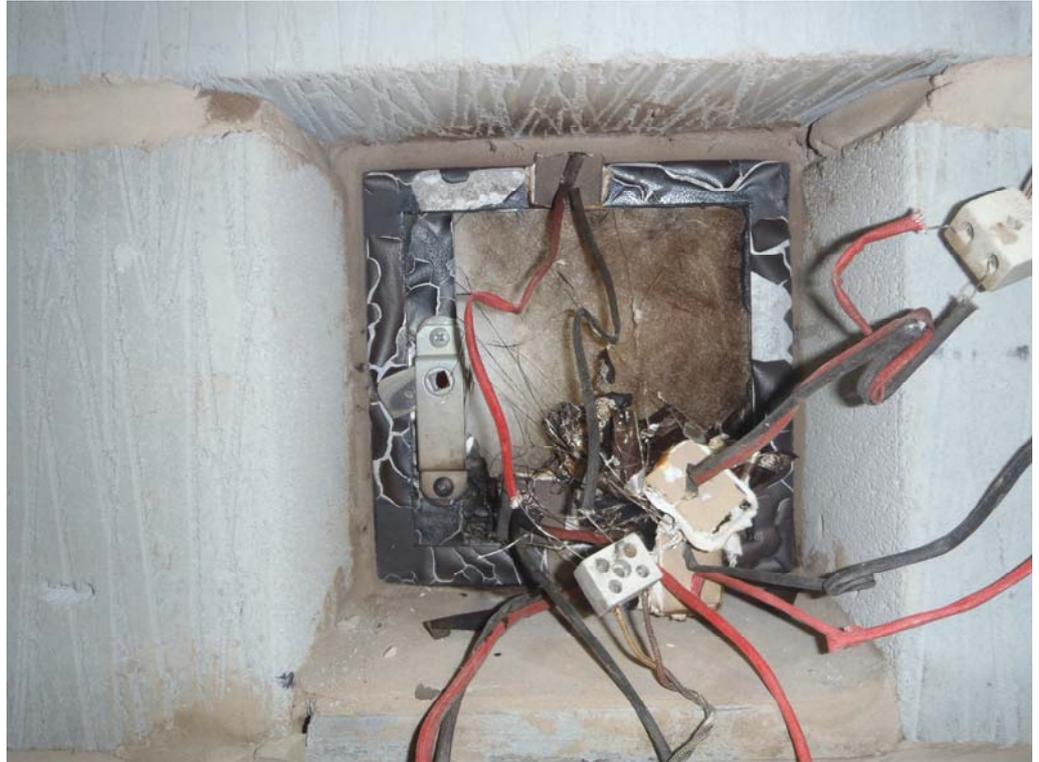
The unexposed
face of Specimen
A after a test
duration of 20
minutes

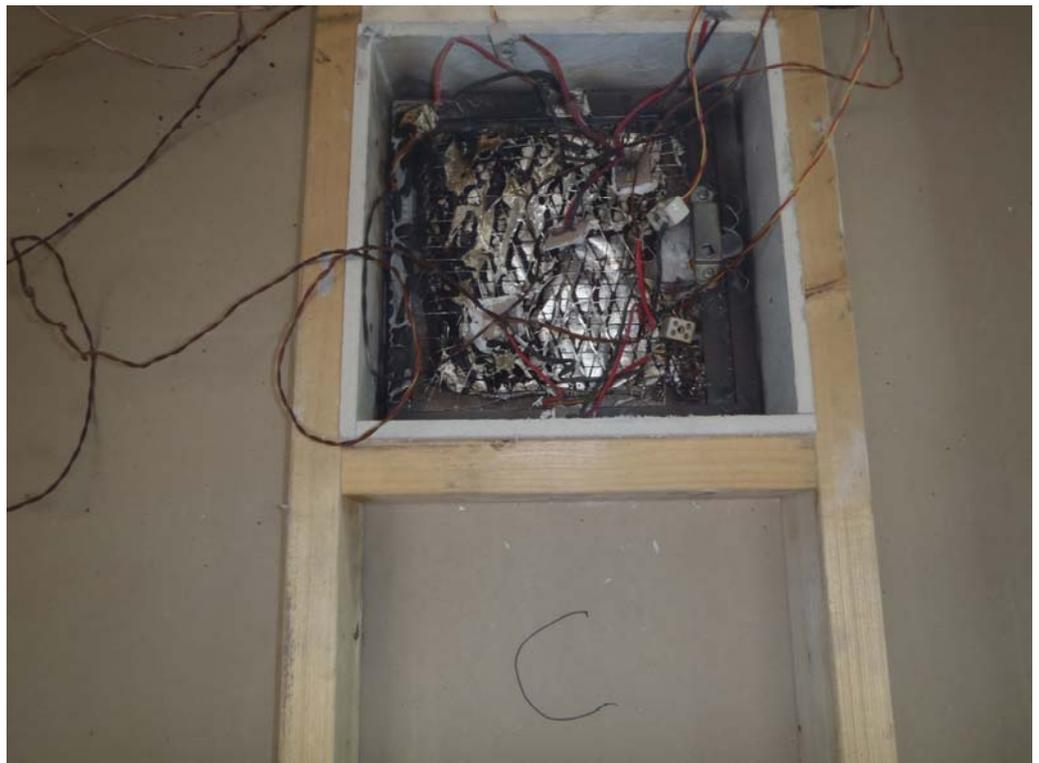
The unexposed
face of Specimen
C after a test
duration of 20
minutes

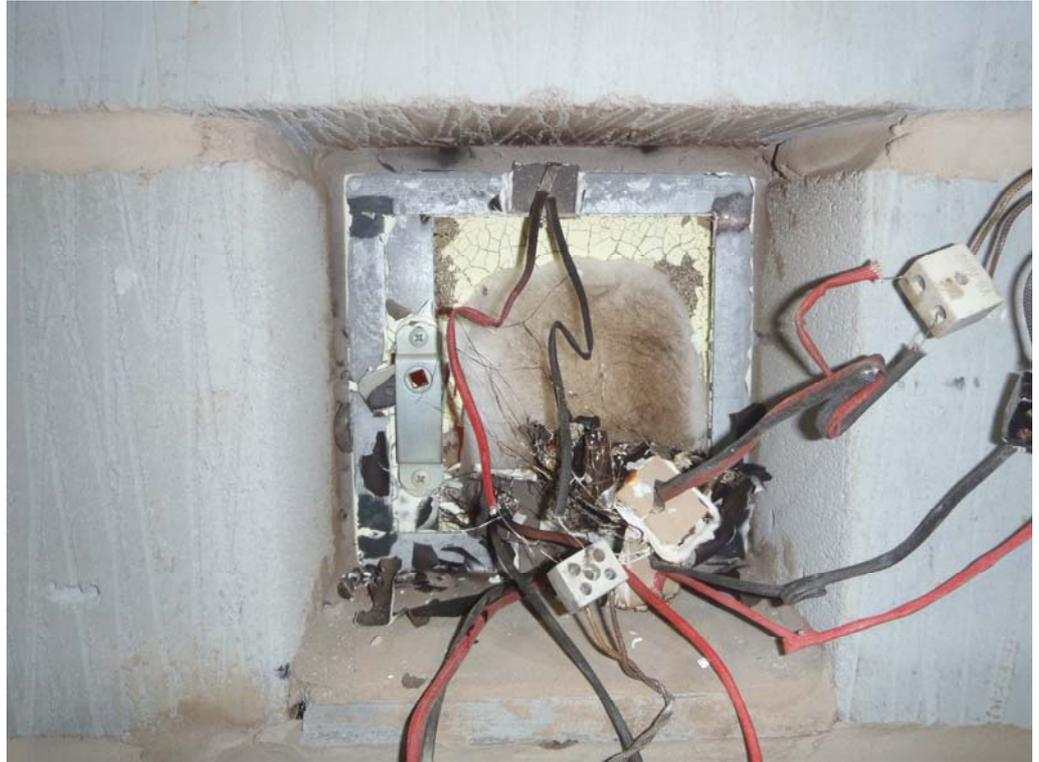
**The unexposed
face of Specimen
A after a test
duration of 30
minutes**

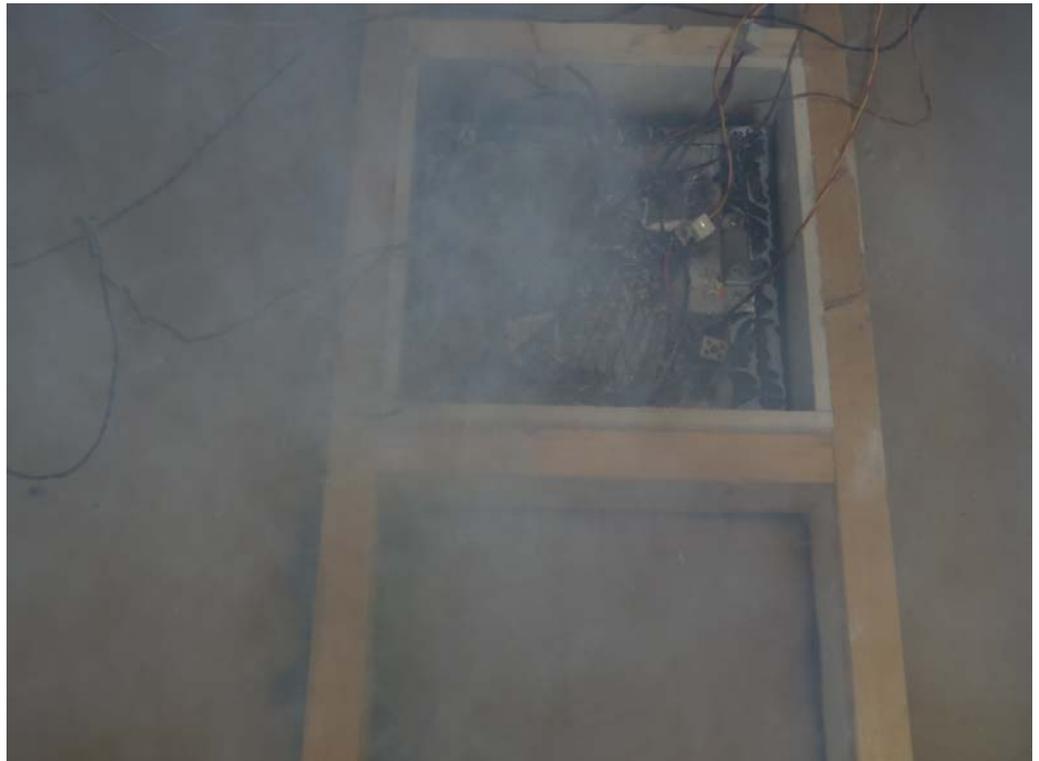
**The unexposed
face of Specimen
C after a test
duration of 30
minutes**

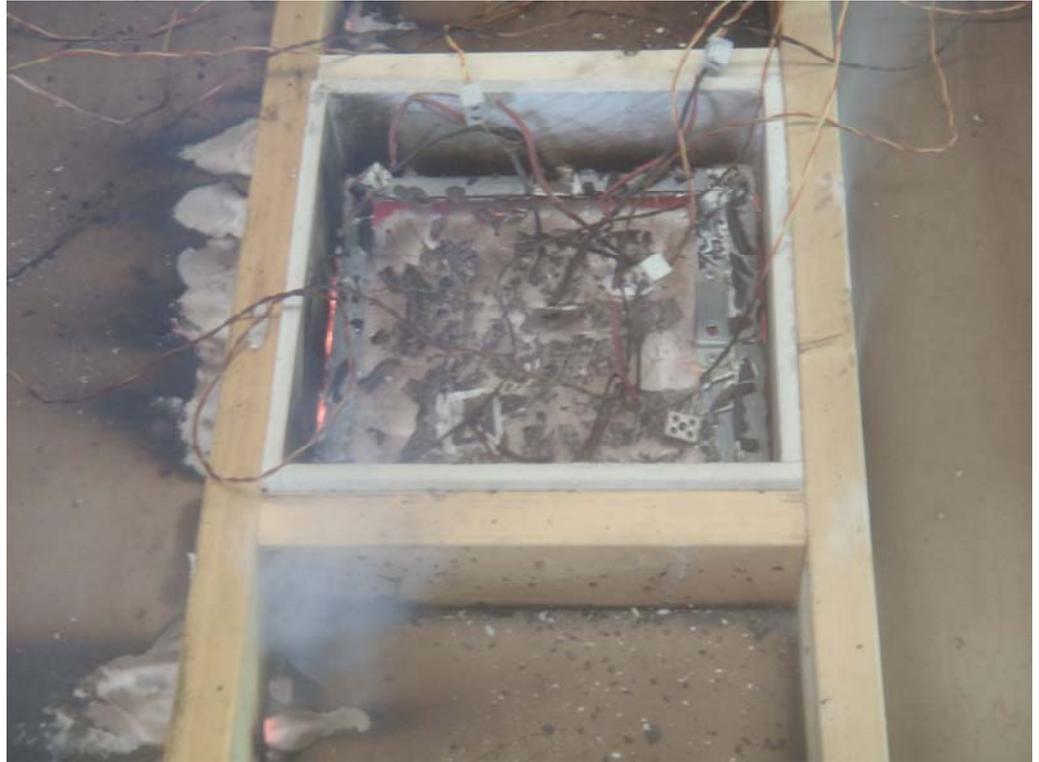
33	00	Sustained flames issue from the plasterboard ceiling along the joists. The flames are sprayed with water to allow the test to continue.
35	40	The mineral wool insulation of Specimen A has slumped down to the bottom half of the specimen. The steel door panel radiates an orange colour.
38	29	The plasterboard ceiling reignites as burn through commences around the timber framework which provides the aperture for Specimen C.
41	30	The aperture lining of Specimen C has discoloured black. Glowing is evident around the perimeter edges of Specimen C.
43	15	The timber joists continue to ignite around Specimen C. The areas are again sprayed with water to allow the test to continue.
51	45	The timber joists continue to ignite around Specimen C. The areas are continually sprayed with water to allow the test to continue.
54	20	Most of the paper face to the unexposed surface of the ceiling has burnt away. The board joints have separated by approximately 6-8 mm along both joints.

The unexposed
face of Specimen
C during the test

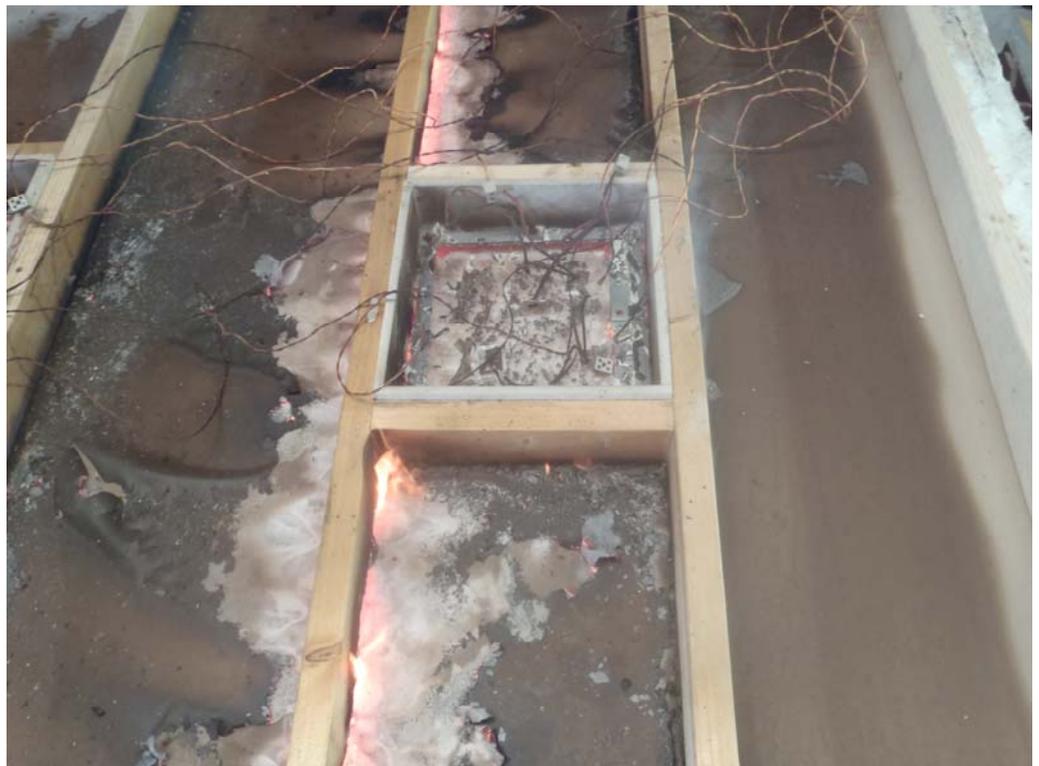
59	20	The central plasterboard panel begins to vibrate up and down.
60	00	No significant visible change. The test is discontinued as the ceiling continues to degrade.

The unexposed
face of Specimen
C during the test

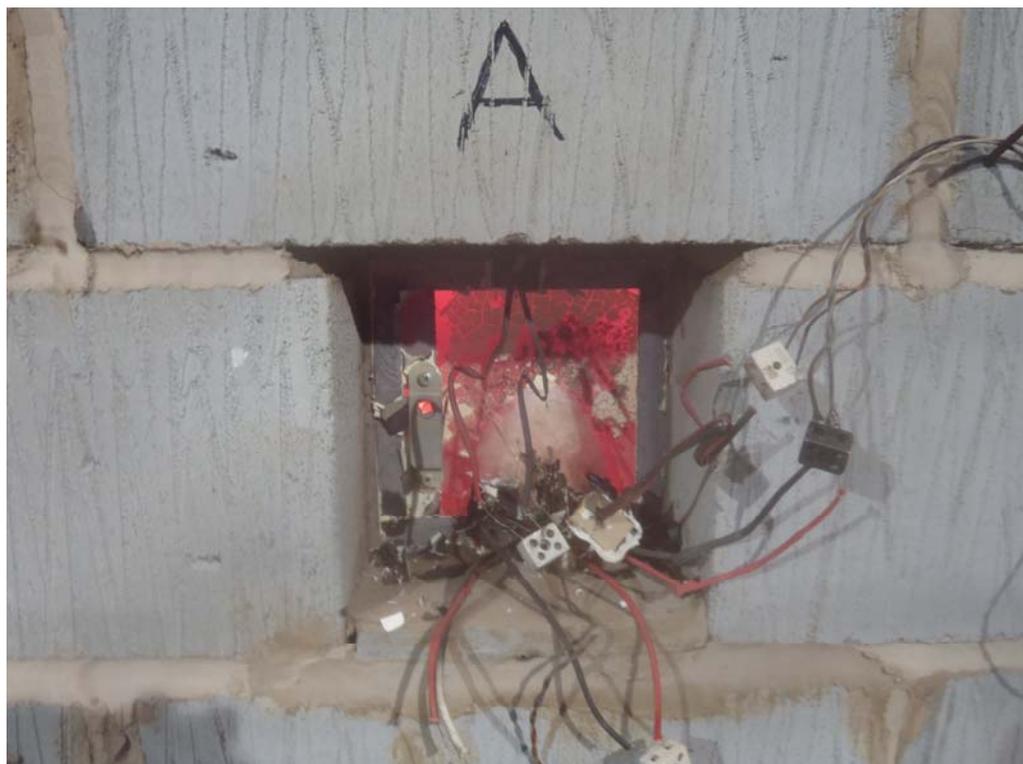
The unexposed
face of Specimen
A after a test
duration of 60
minutes
