The Fire Resistance Performance Of Two Specimens Of Vertical Mounted And Three Specimens Of Horizontal Mounted Cavity Barrier Systems, When Tested In General Accordance With EN 1366-4:2006+A1:2010

432893/R

**Timloc Building Products**

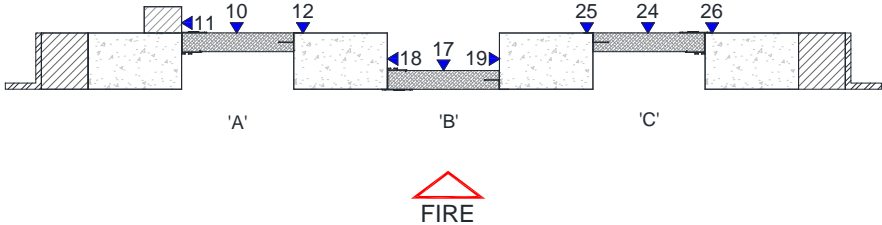
**Figure 1- General Plan View of Horizontal Test Construction and Unexposed Face Thermocouples**

■/▼ Positions of surface thermocouples

GENERAL PLAN VIEW OF FLOOR TEST CONSTRUCTION  
SHOWING THERMOCOUPLE LOCATIONS

VERTICAL SECTION THROUGH FLOOR TEST CONSTRUCTION  
SHOWING THERMOCOUPLE LOCATIONS

<b>Thermocouples</b>	<p>Thermocouples were provided to monitor the unexposed surface of the specimens. The output of all instrumentation was recorded at no less than one minute intervals. The locations and reference numbers of the various unexposed surface thermocouples are shown in Figures 1 and 6.</p>

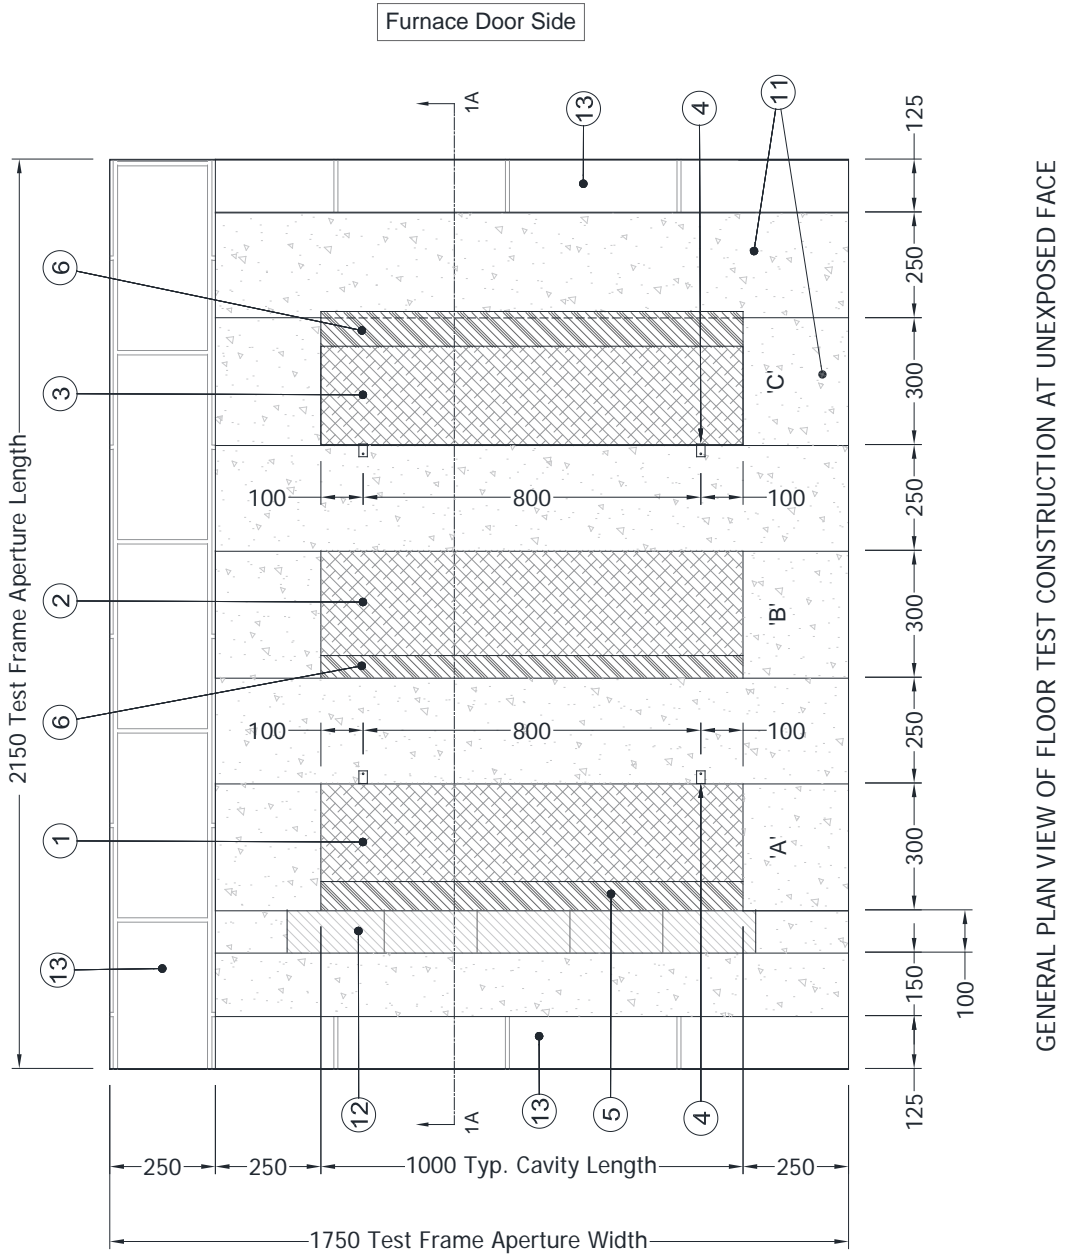
**Figure 2 – General Plan View of Horizontal Test Construction at Unexposed Face**

GENERAL PLAN VIEW OF FLOOR TEST CONSTRUCTION AT UNEXPOSED FACE

Material	: Autoclaved aerated concrete blocks
Density	: 760 kg/m <sup>3</sup>
Overall sizes	: See Figures 2,3,7 & 8
Fixing method	: Ordinary sand/cement mortar mix

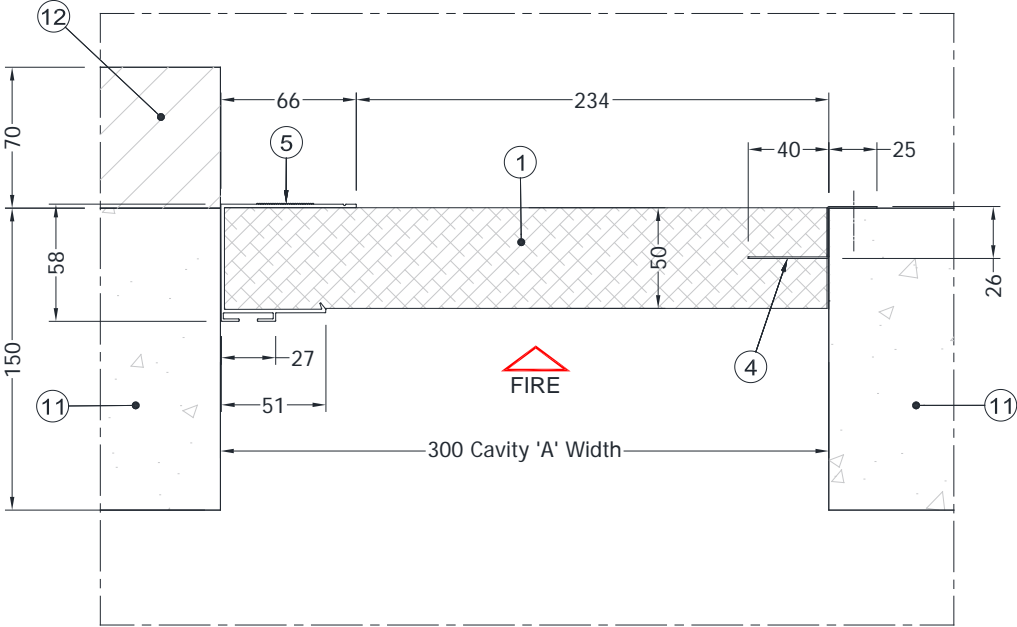
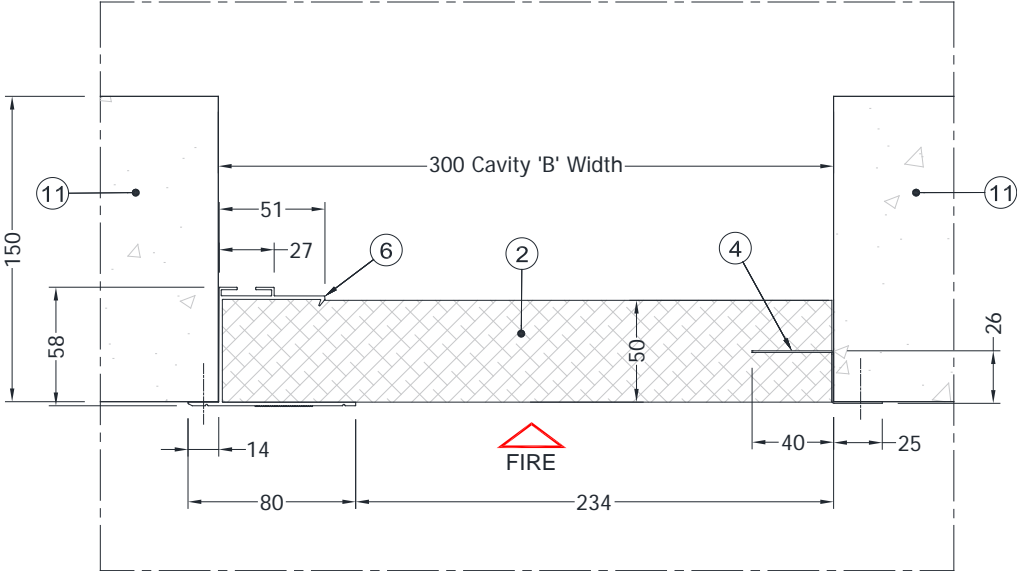
**Figure 4 – Details 'A' & 'B'**

DETAIL 'A'

DETAIL 'B'

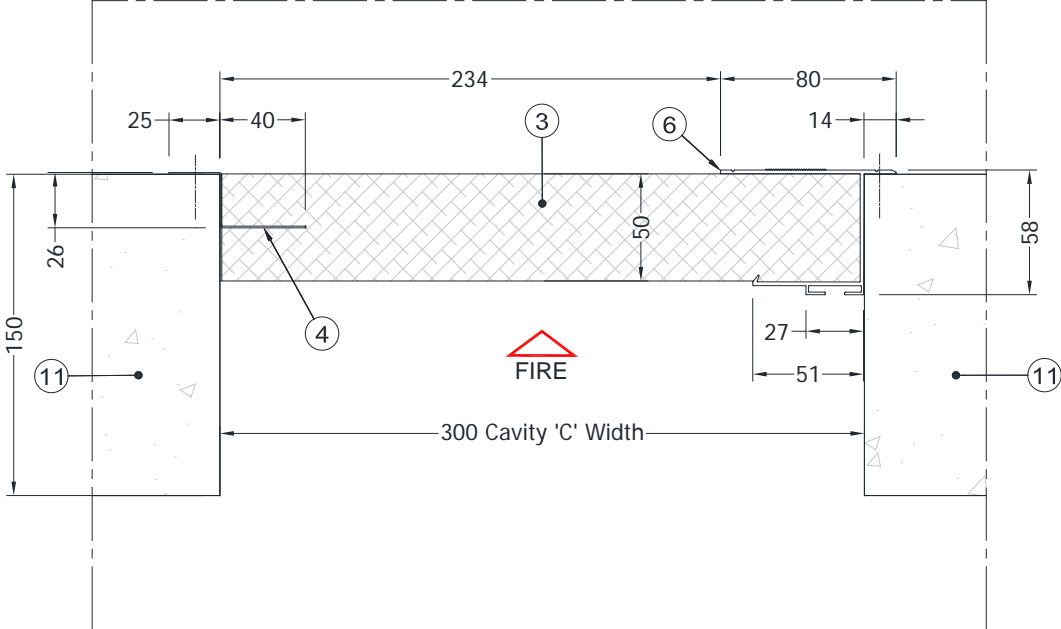
**Figure 5 – Detail 'C'**

DETAIL 'C'

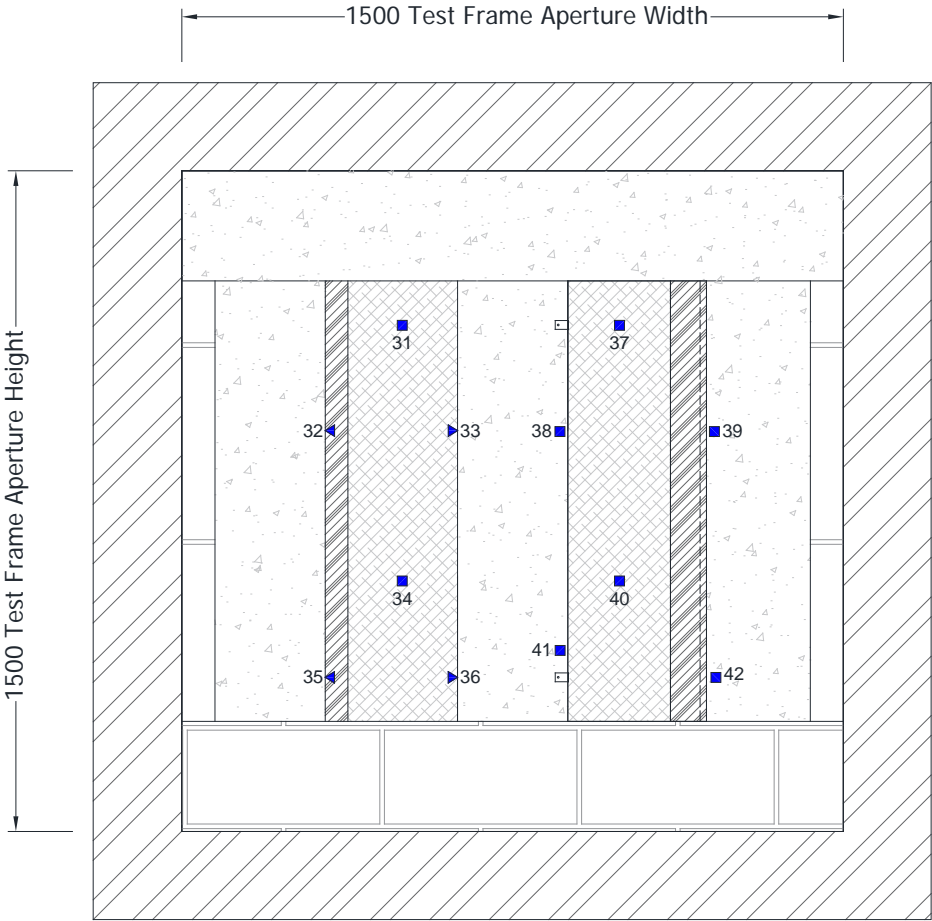
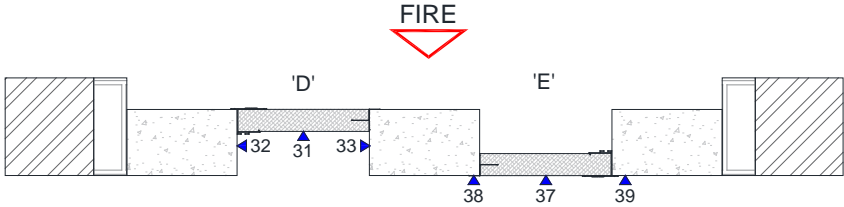
**Figure 6 – General Elevation of Vertical Test Construction and Unexposed Face Thermocouples**

■/▼ Positions of surface thermocouples

GENERAL ELEVATION OF WALL TEST CONSTRUCTION  
SHOWING THERMOCOUPLE LOCATIONS

HORIZONTAL SECTION THROUGH WALL TEST CONSTRUCTION  
SHOWING THERMOCOUPLE LOCATIONS

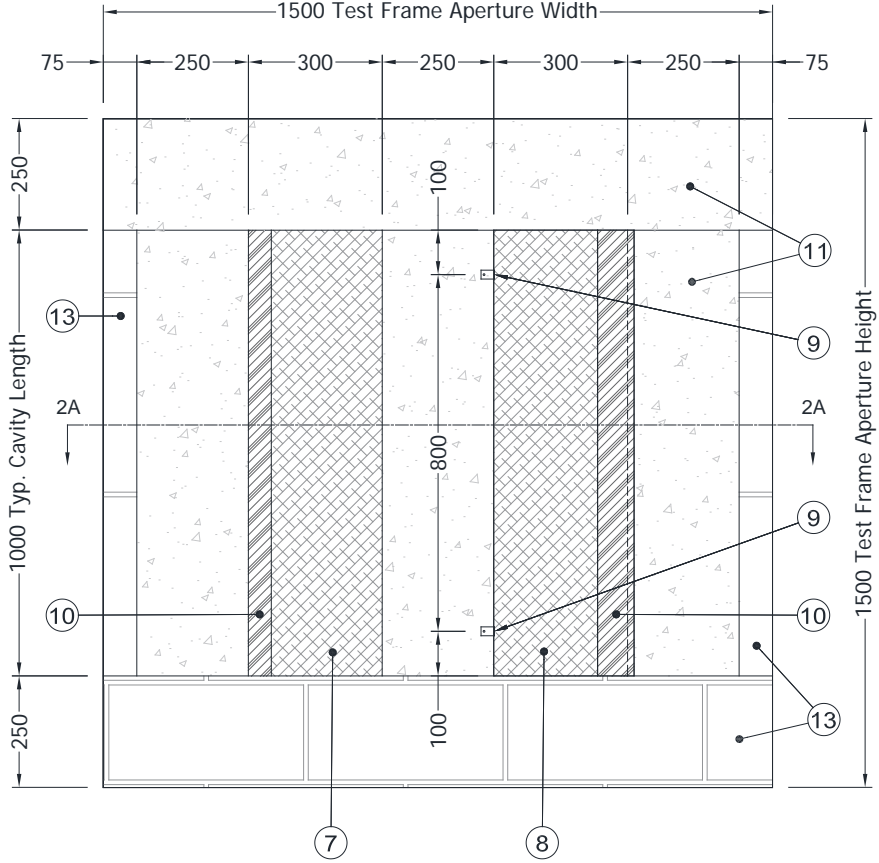
**Figure 7 – General Elevation of Vertical Test Construction at Unexposed Face**

GENERAL ELEVATION OF WALL TEST CONSTRUCTION AT UNEXPOSED FACE

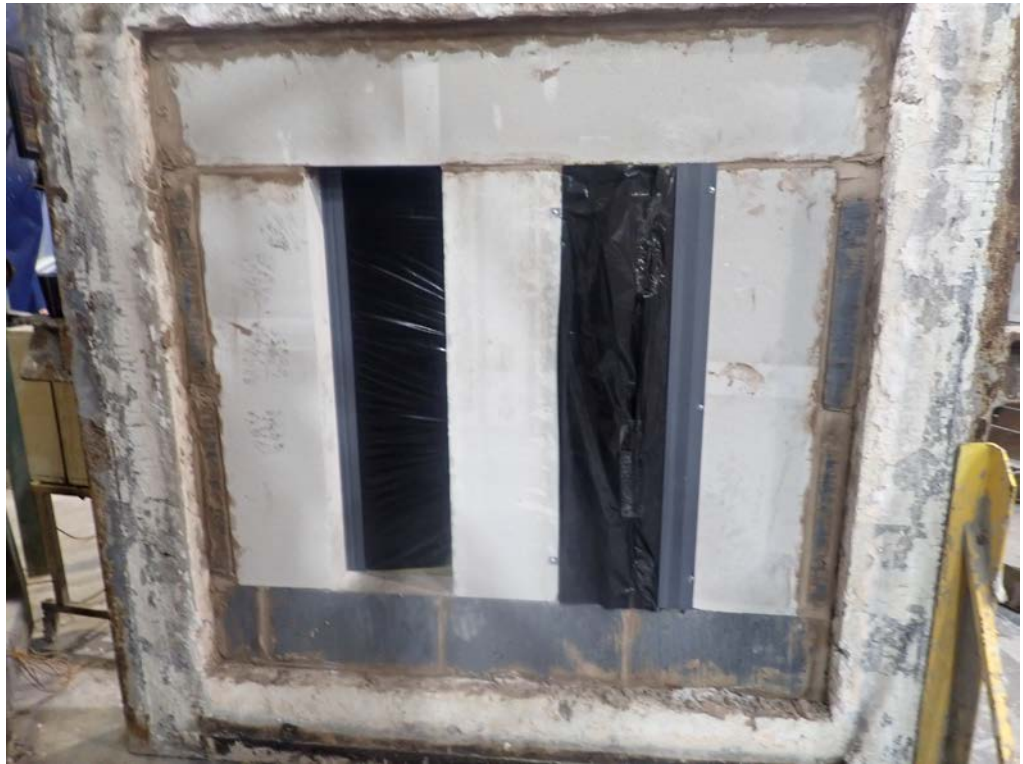
The exposed face of the vertical assembly prior to testing

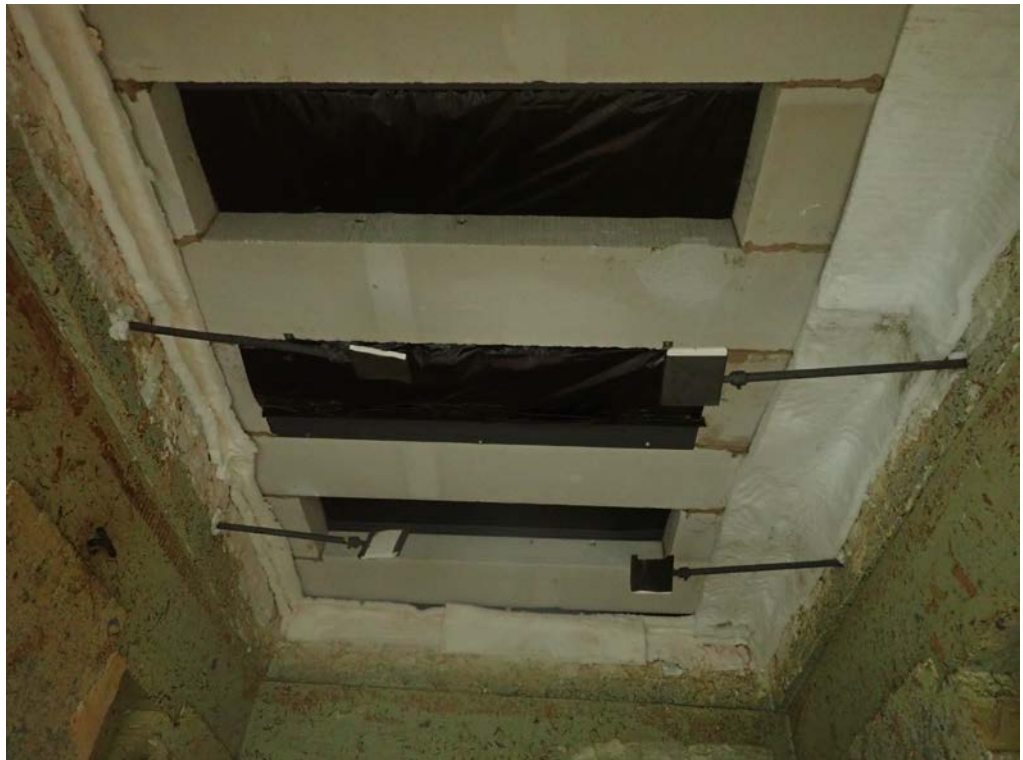
The exposed face of the horizontal assembly prior to testing

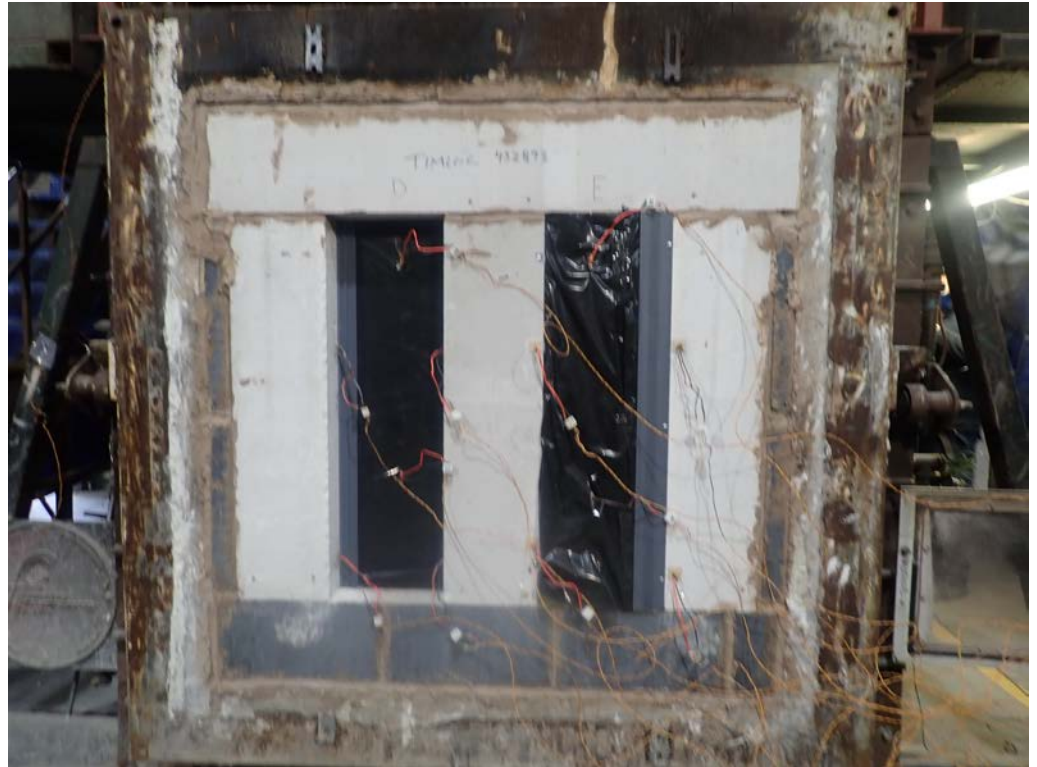
The unexposed face of the vertical assembly prior to the start of the test

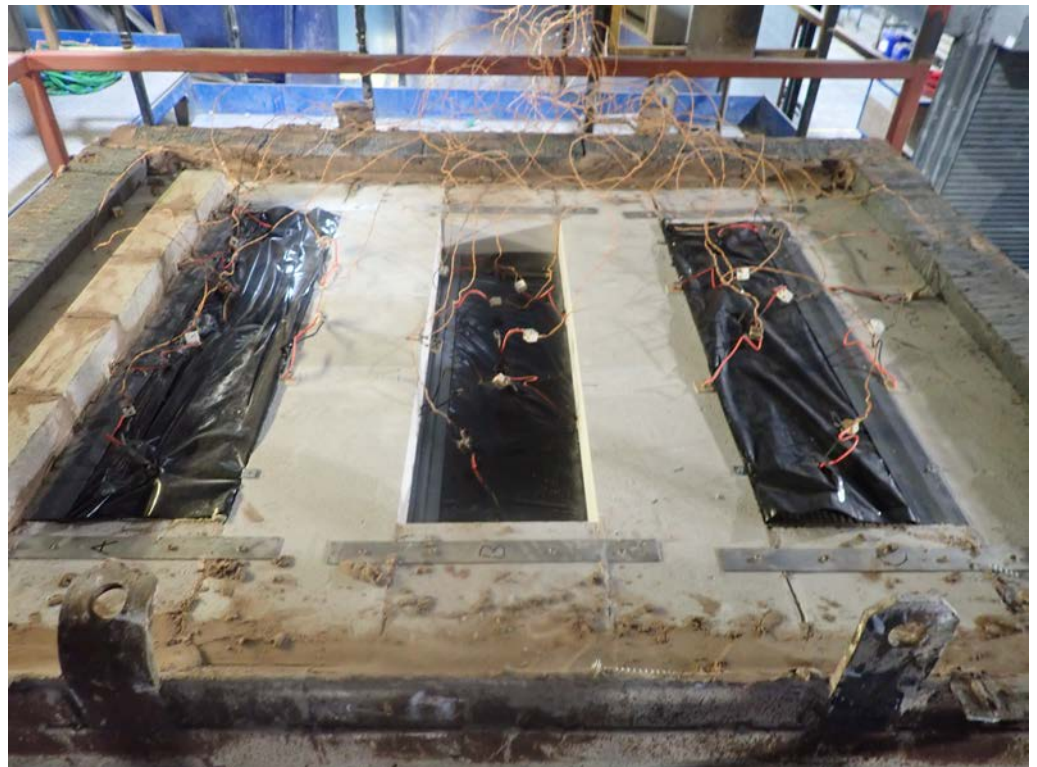
The unexposed face of the horizontal assembly prior to the start of the test

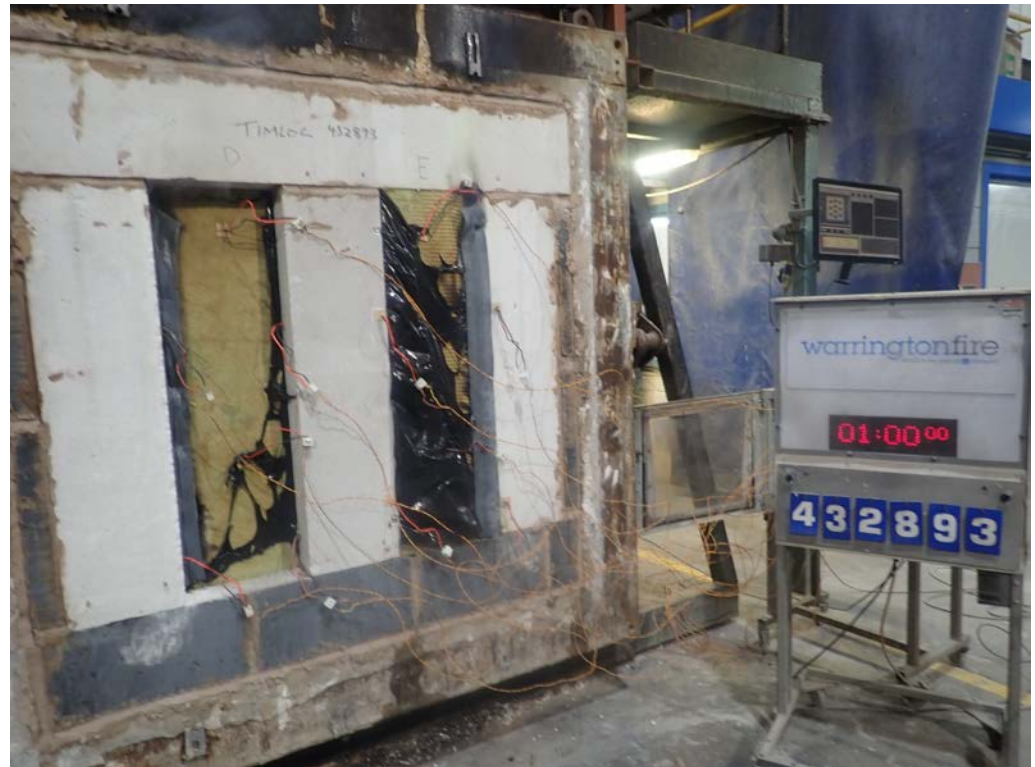
The unexposed face of the vertical assembly after a test duration of 60 minutes

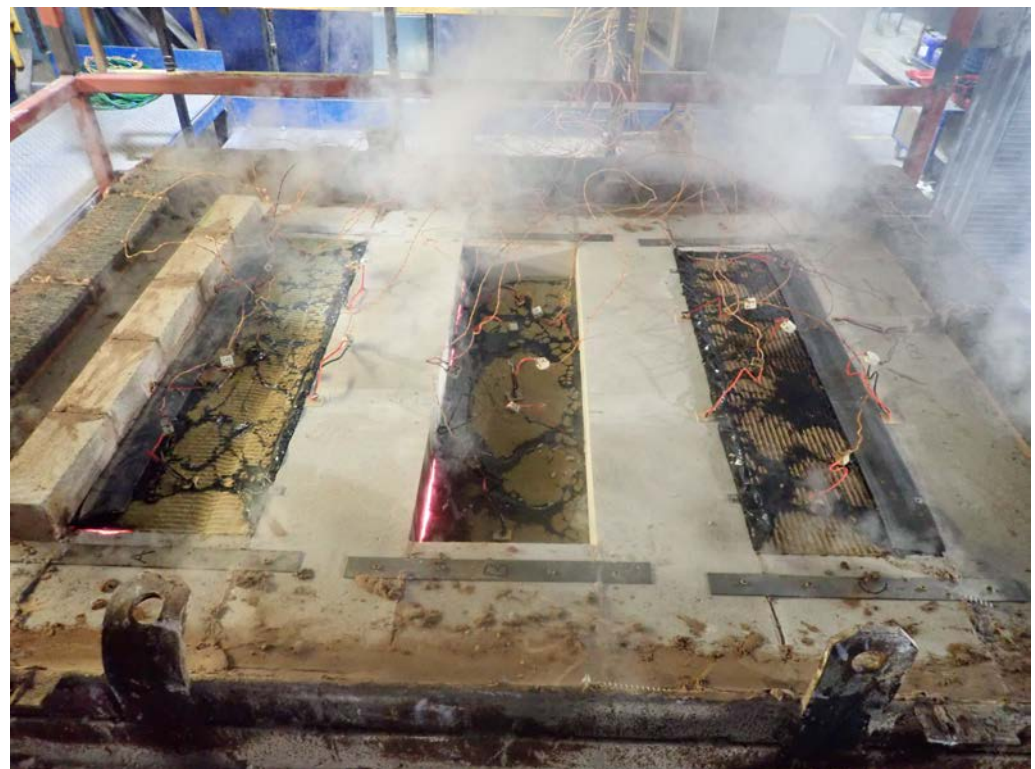
The unexposed face of the horizontal assembly after a test duration of 60 minutes

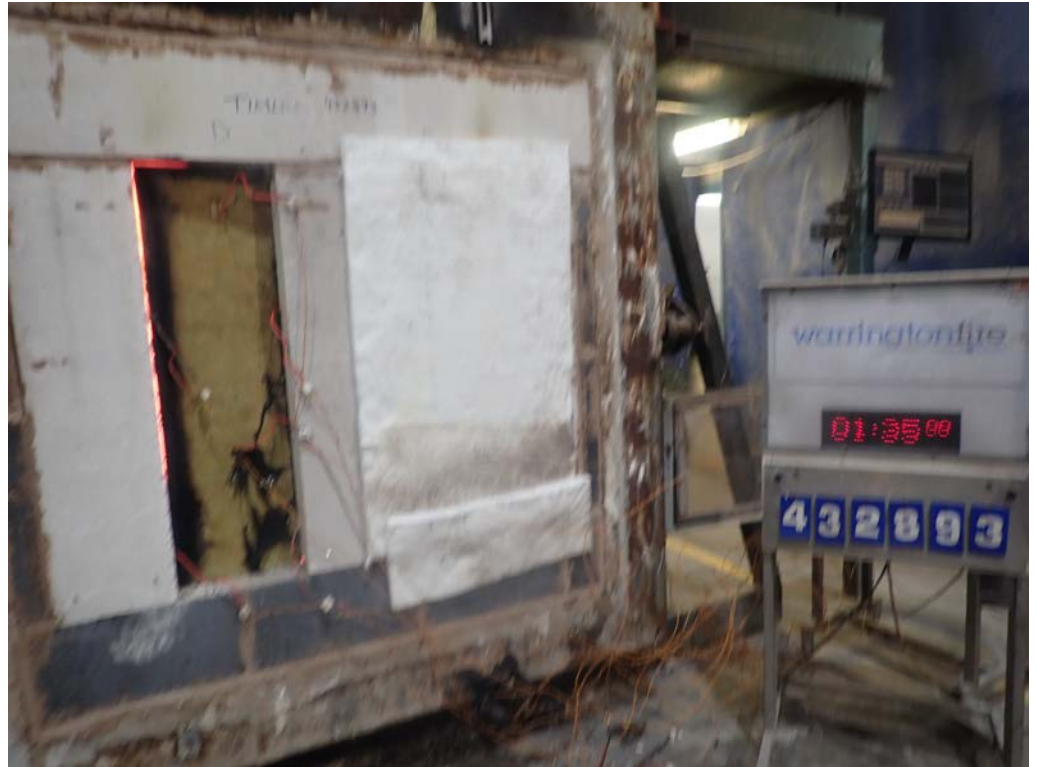
The unexposed face of the vertical assembly after a test duration of 95 minutes

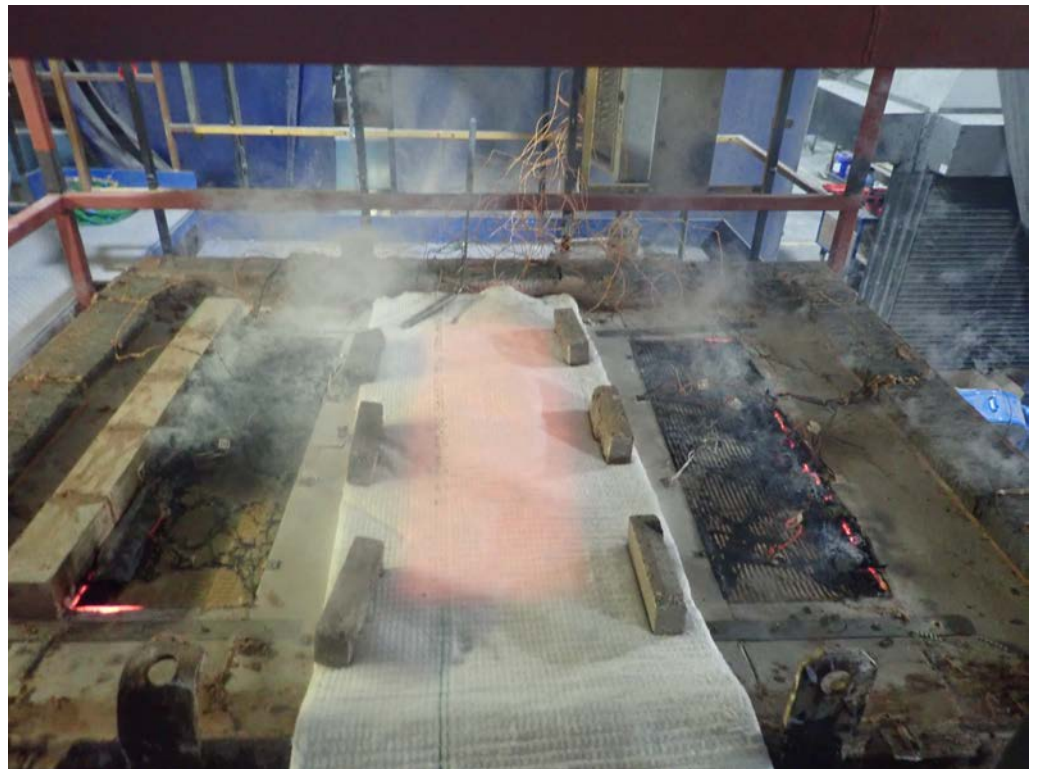
The unexposed face of the horizontal assembly after a test duration of 95 minutes

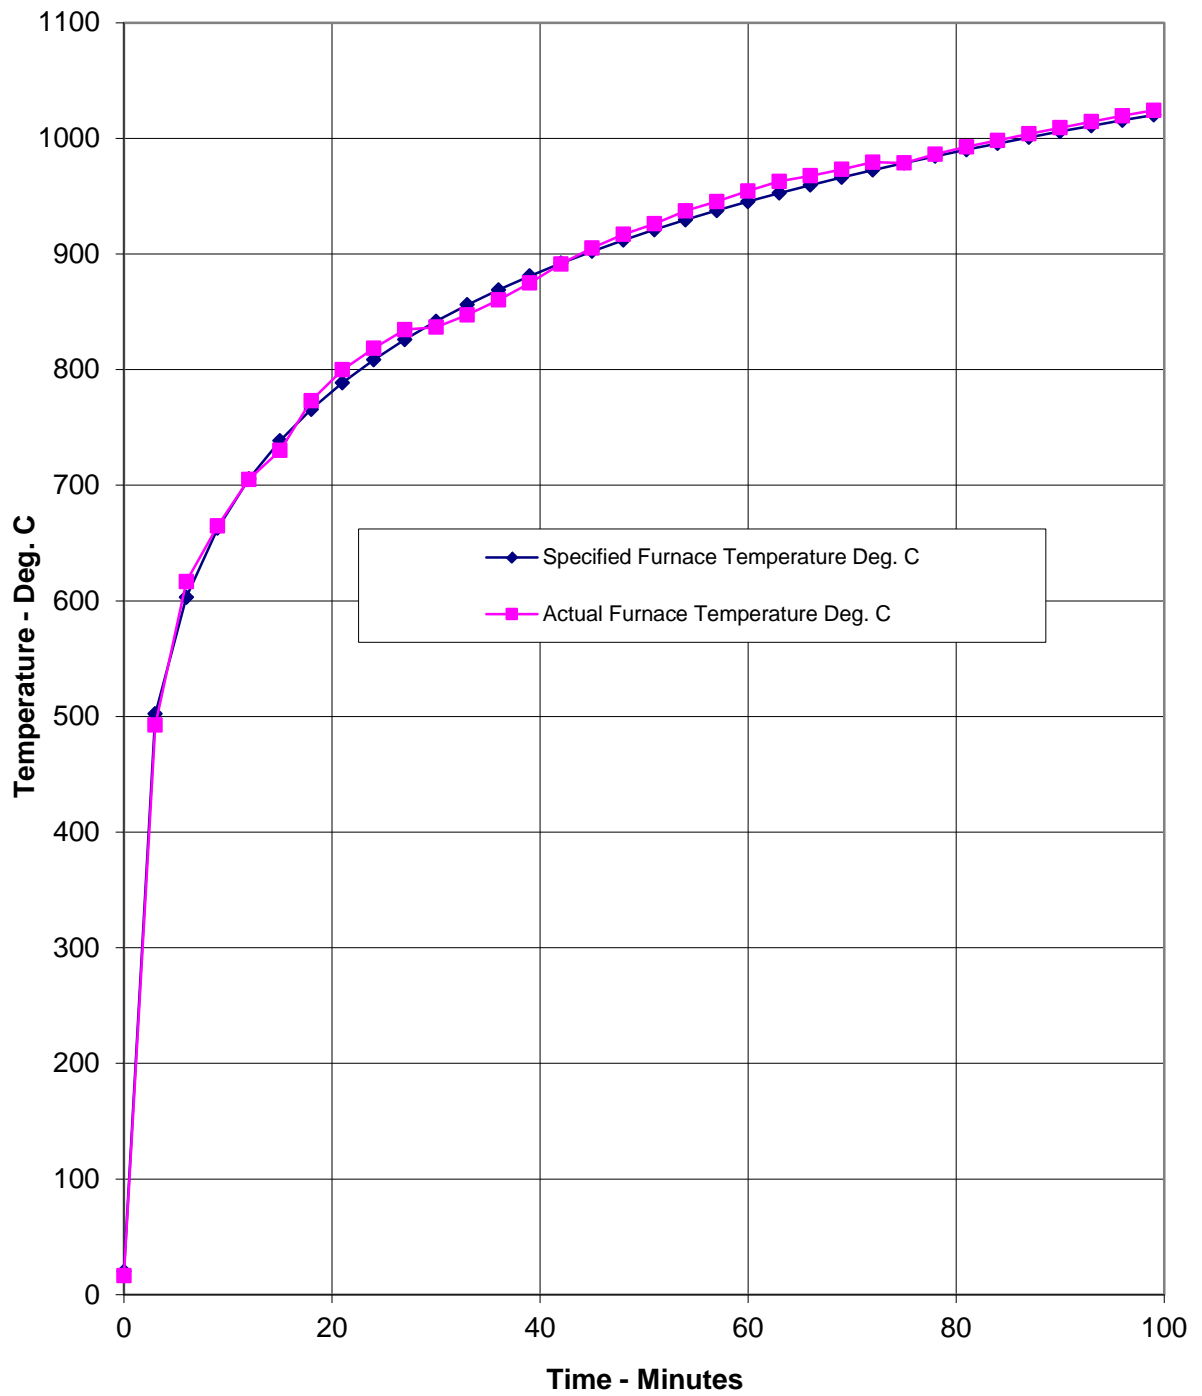
**Graph showing mean furnace temperature, together with the temperature/time relationship specified in BS EN 1363-1: 2020**

Time Mins	Specified Furnace Temperature Deg. C	Actual Furnace Temperature Deg. C
0	20	17
3	502	493
6	603	617
9	663	665
12	705	705
15	739	730
18	766	773
21	789	800
24	809	818
27	826	835
30	842	837
33	856	847
36	869	860
39	881	875
42	892	891
45	902	905
48	912	917
51	921	926
54	930	937
57	938	945
60	945	955
63	953	963
66	960	968
69	966	973
72	973	979
75	979	979
78	985	986
81	990	993
84	996	998
87	1001	1004
90	1006	1009
93	1011	1014
96	1016	1020
99	1020	1024

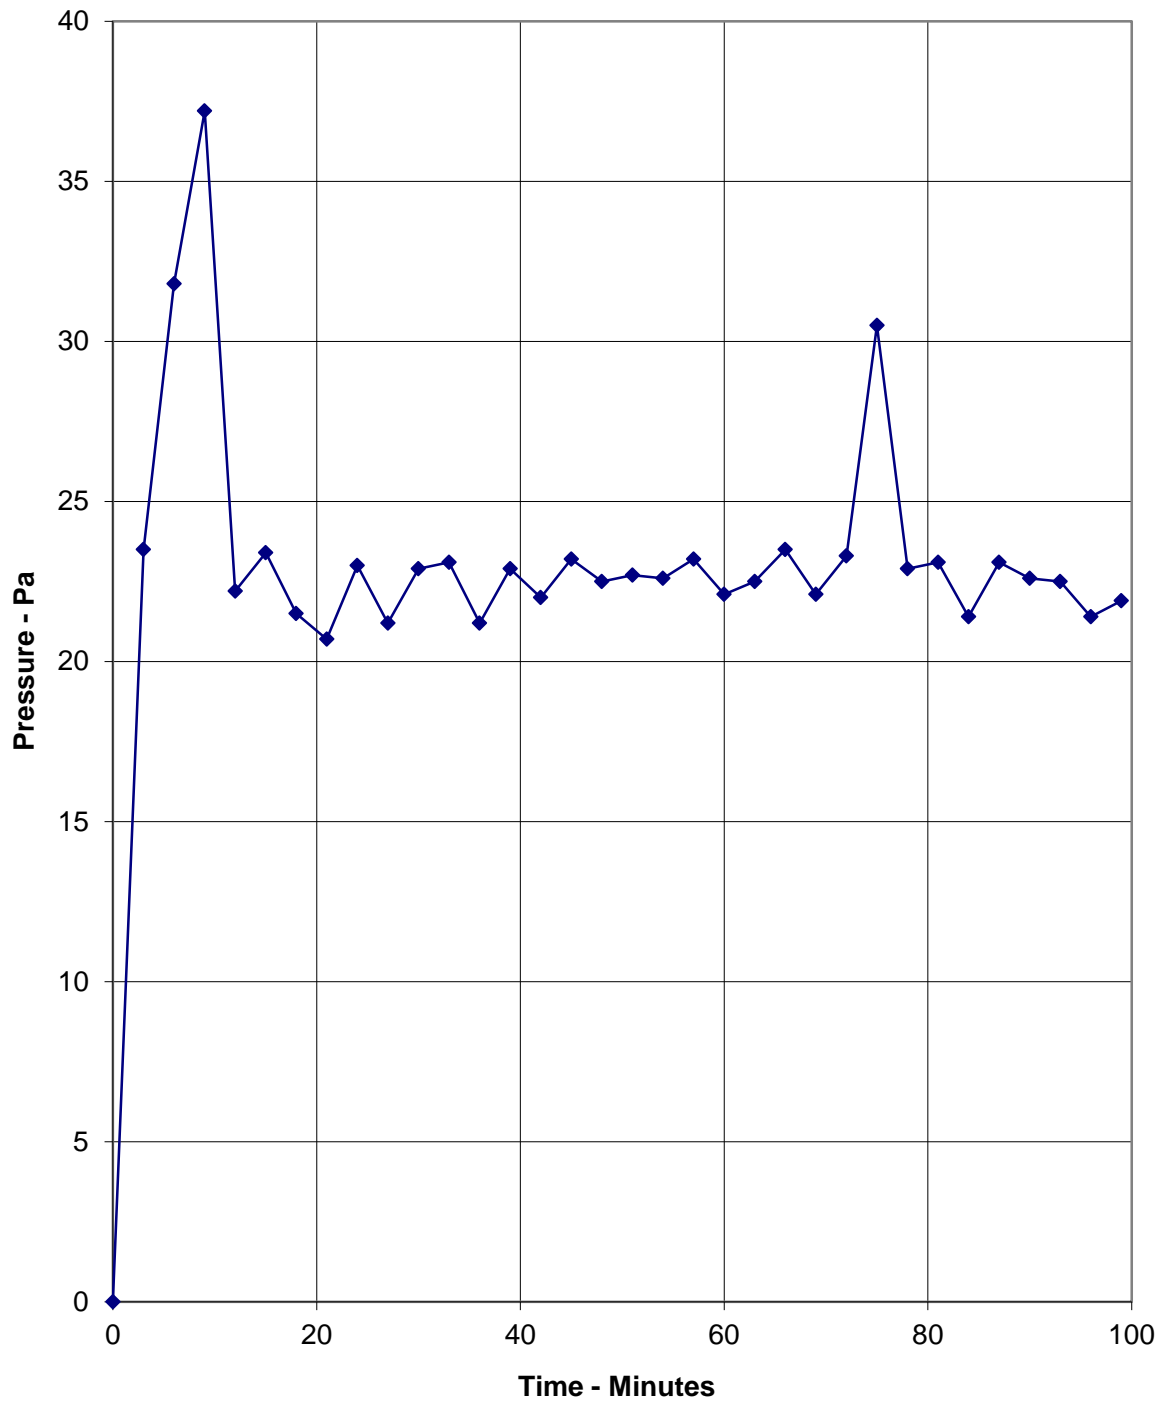
Graph showing recorded furnace pressure 270 mm above the head of the vertical specimens

The requirements of BS EN 1366-4: 2006+A1:2010, clause 5.2 could not be satisfied due to simultaneous testing of vertical and horizontal specimens. The horizontal specimens were tested under more onerous conditions, at position 100 mm below the underside of the horizontal assembly the differential pressure was calculated to be 25 ( $\pm$  5) Pa between 5 and 10 minutes and 25 ( $\pm$  3) Pa respectively thereafter. The vertical specimens satisfied the requirements of BS EN 1366-4: 2006+A1:2010, clause 5.2. The calculated pressure differential relative to the laboratory atmosphere at mid height of the lowest mounted vertical specimens was 15 ( $\pm$  5).
