The fire resistance performance of 2 no. Vertical and 2 no. Horizontal linear joint seals, when tested in accordance with BS EN 1366-4:2021 and BS EN 1363-1:2020

WF 527278

Timloc Building Products

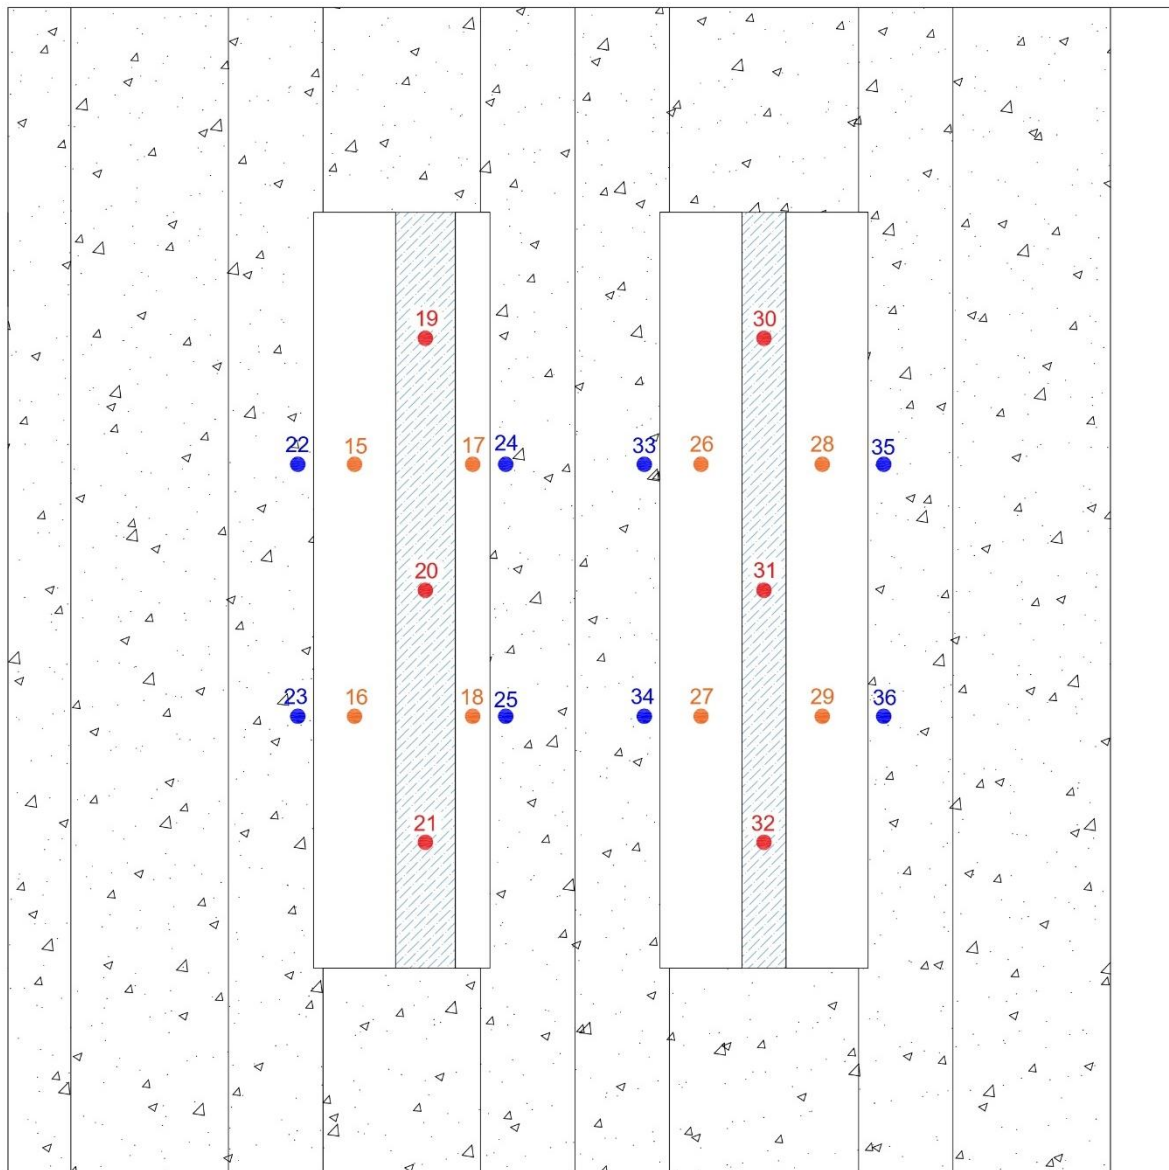
Figure 3 – Thermocouple Locations – Specimens A & B

- : Thermocouples on PVC
- : Thermocouples on Joint Seal
- : Thermocouples on Supporting Construction

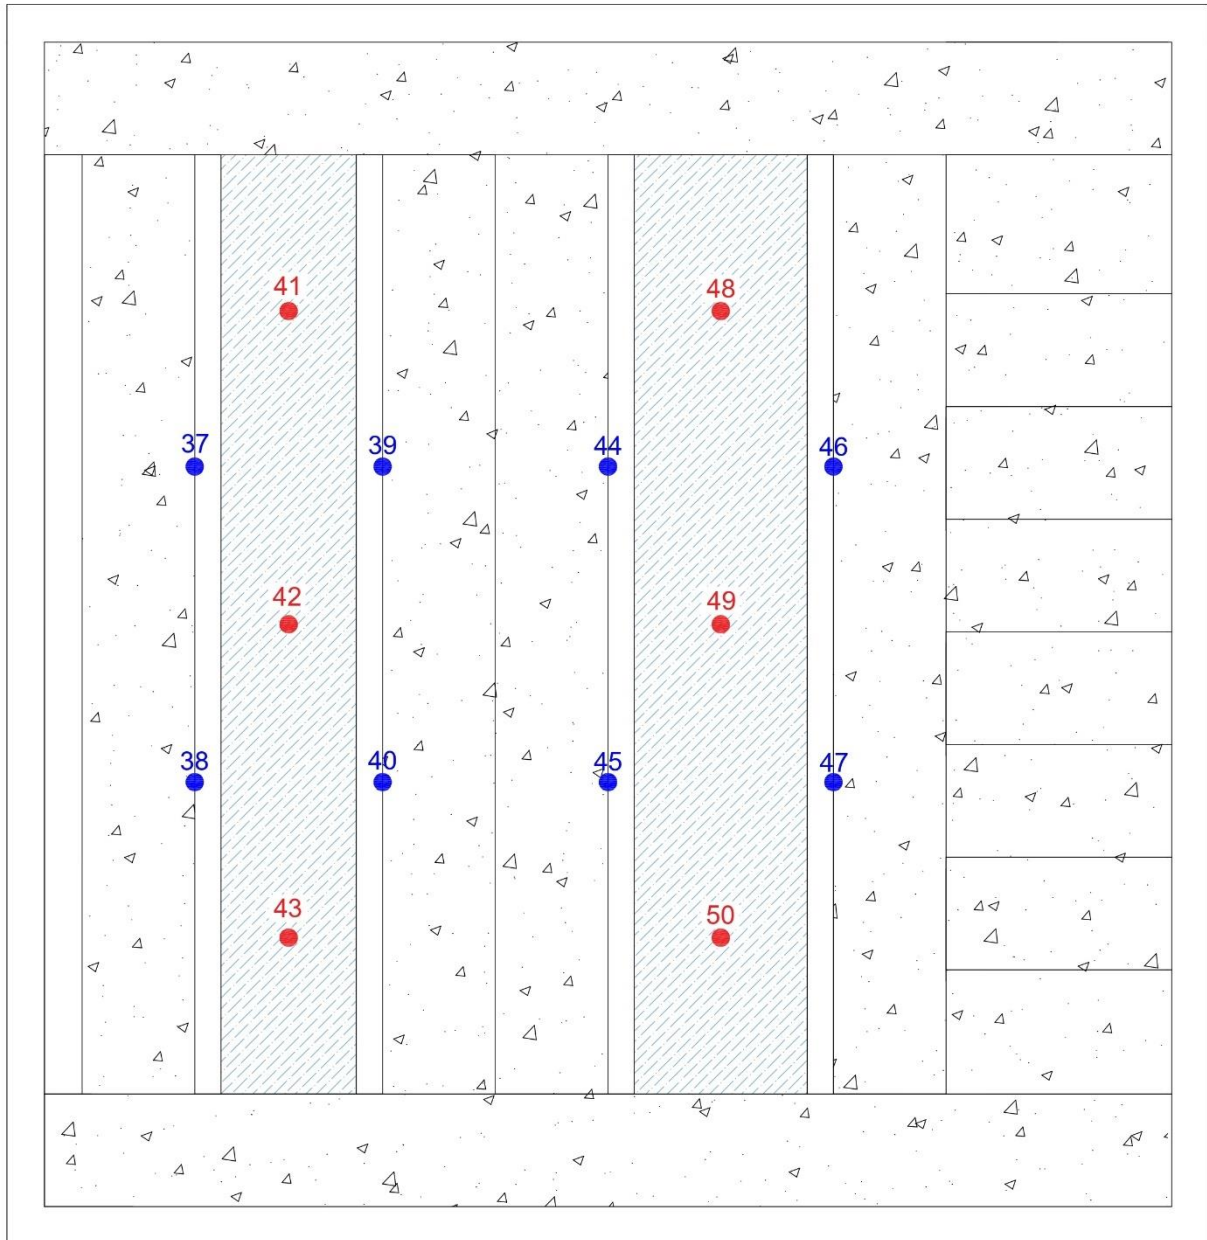
Figure 6 – Thermocouple Locations – Specimens C & D

- : Thermocouples on Joint Seal
- : Thermocouples on Supporting Construction

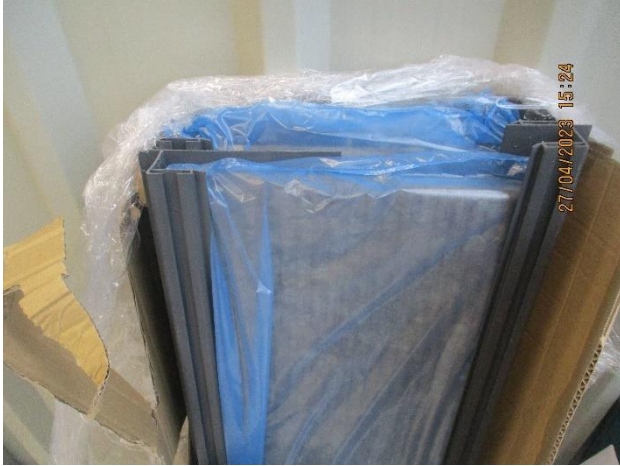
Cavity barrier with plastic extrusion and film

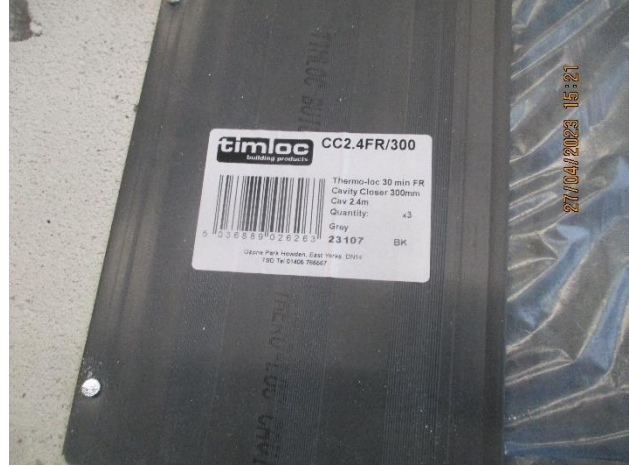
Details of plastic extrusion

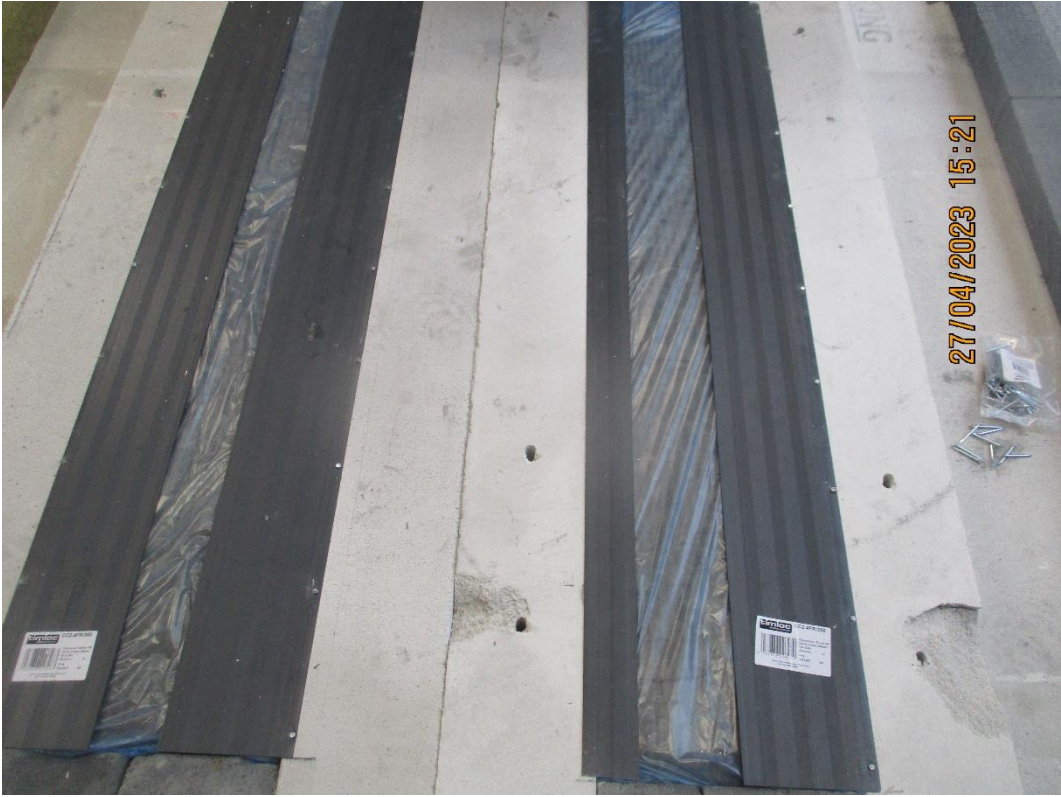
The unexposed horizontal face prior to testing

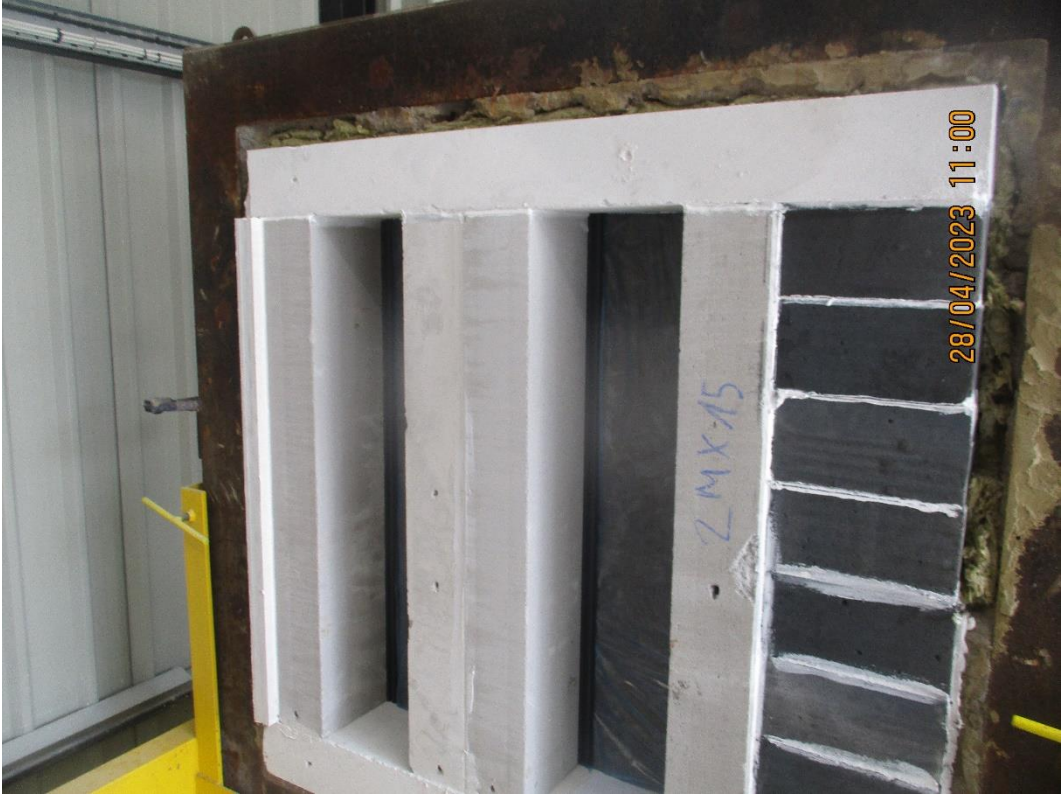
The unexposed vertical face prior to testing

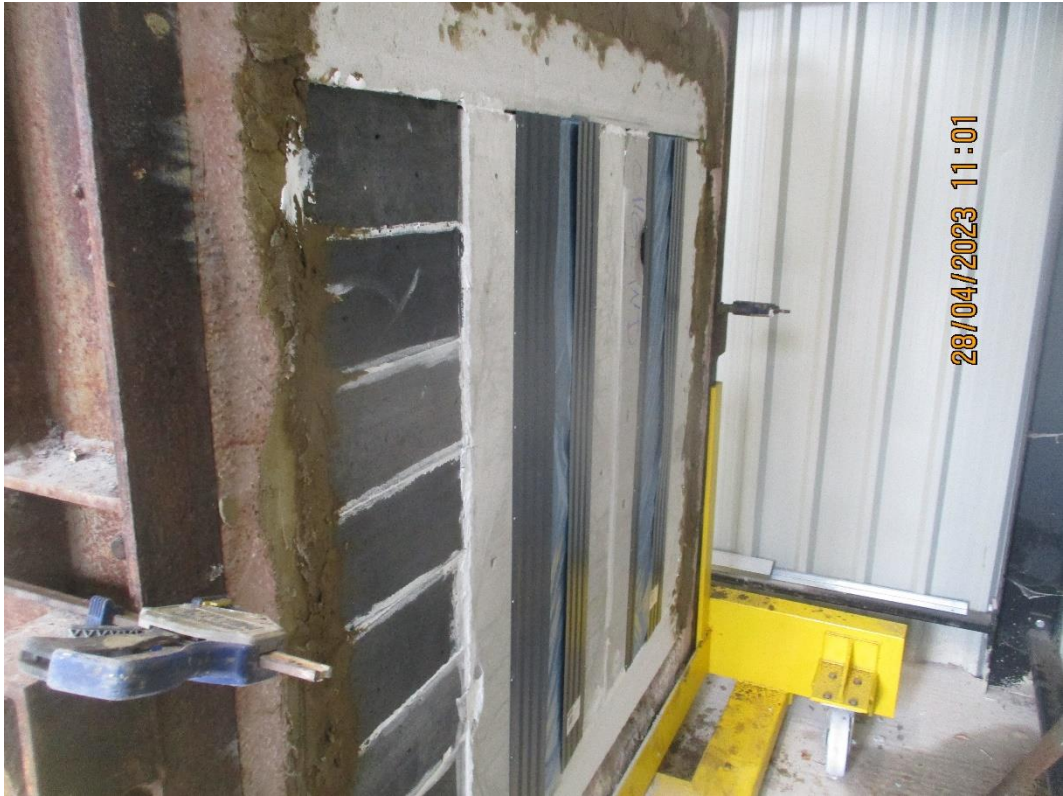
The exposed vertical face prior to testing

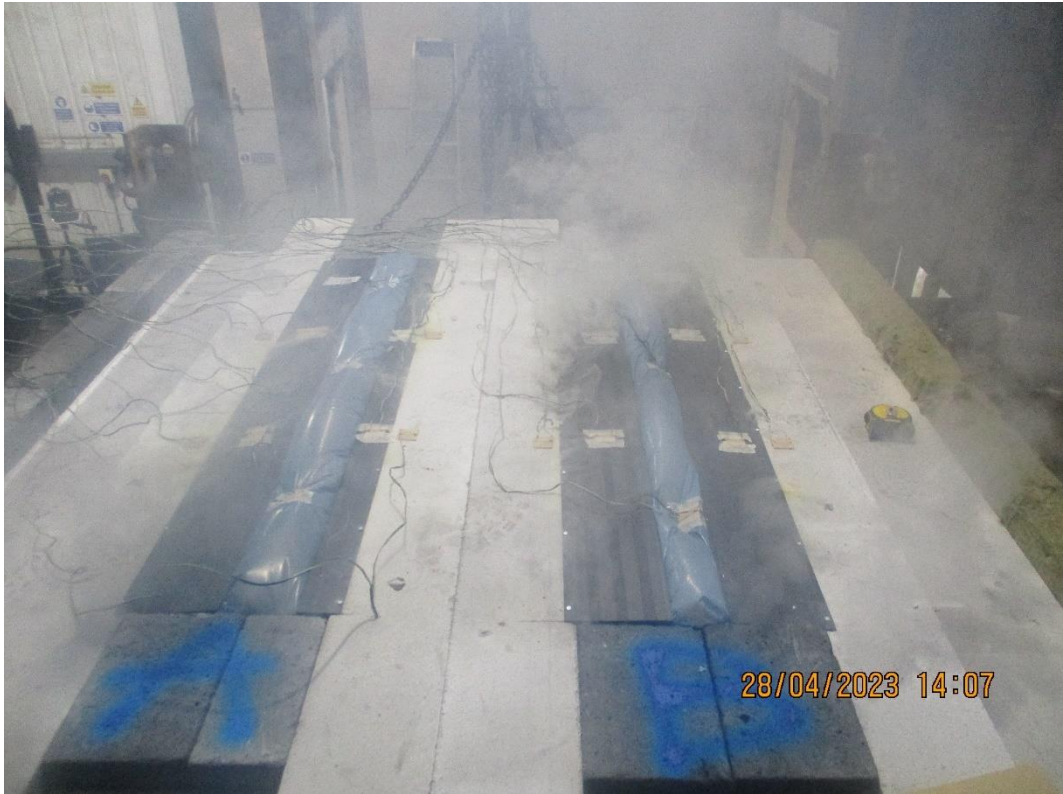
The unexposed horizontal face after a test duration of 5 minutes

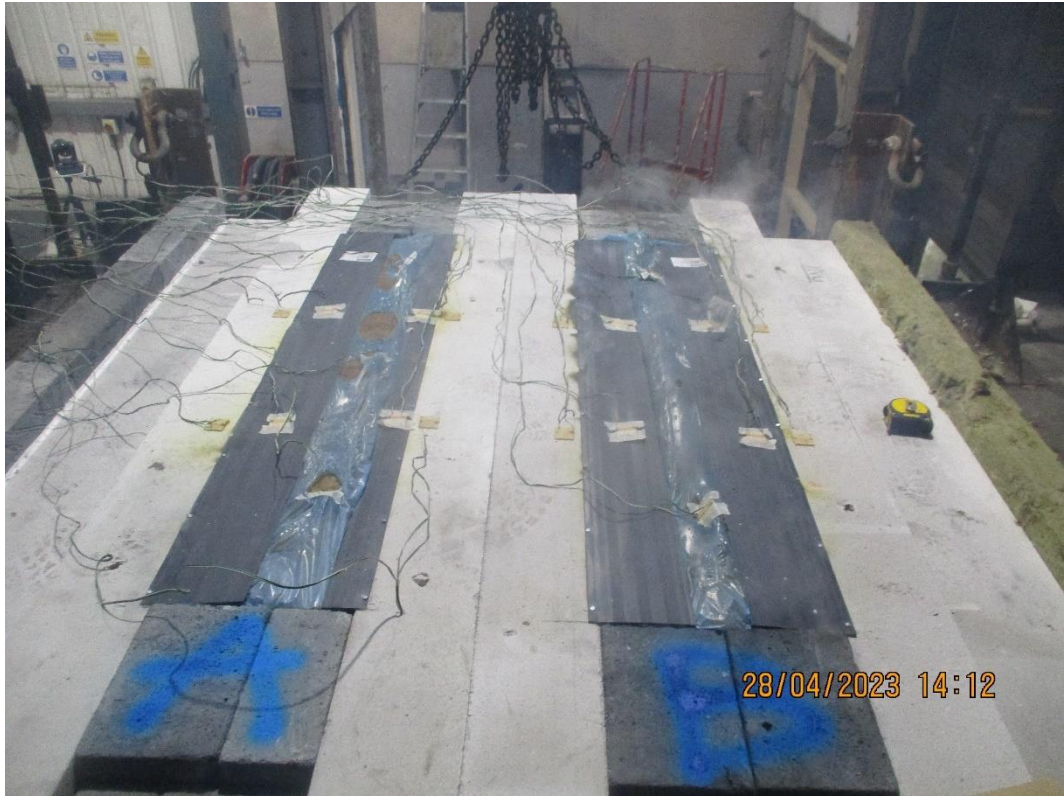
The unexposed horizontal face after a test duration of 10 minutes

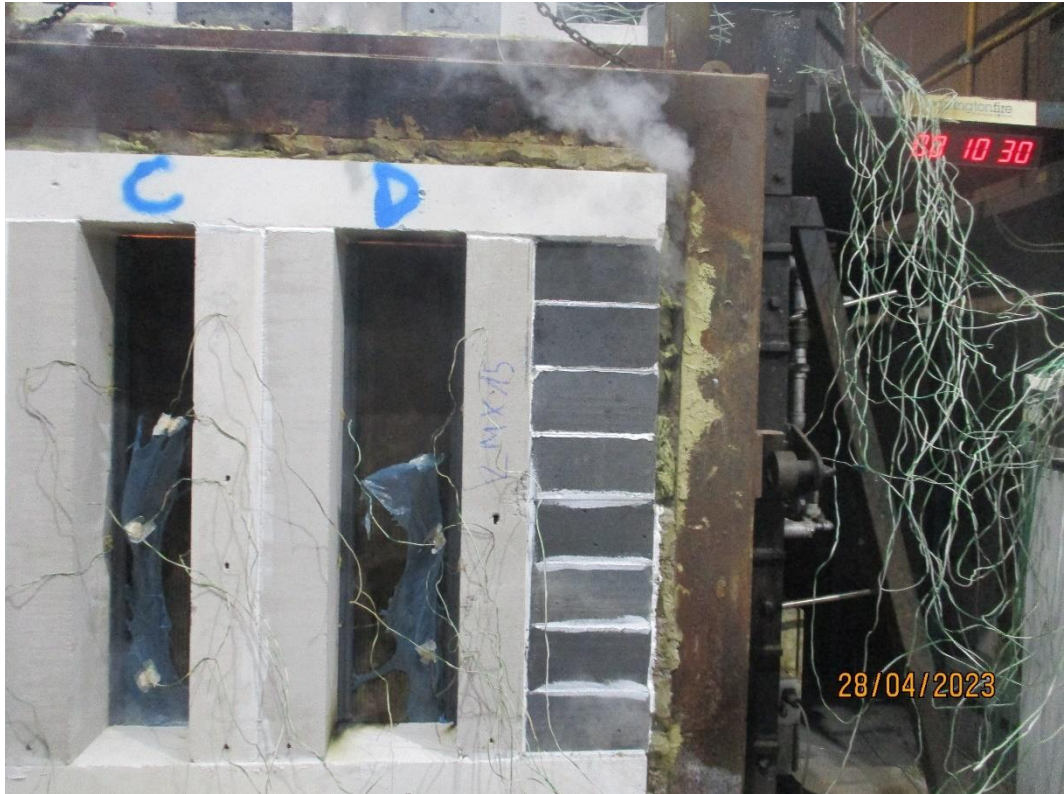
The unexposed vertical face after a test duration of 10 minutes 30 seconds

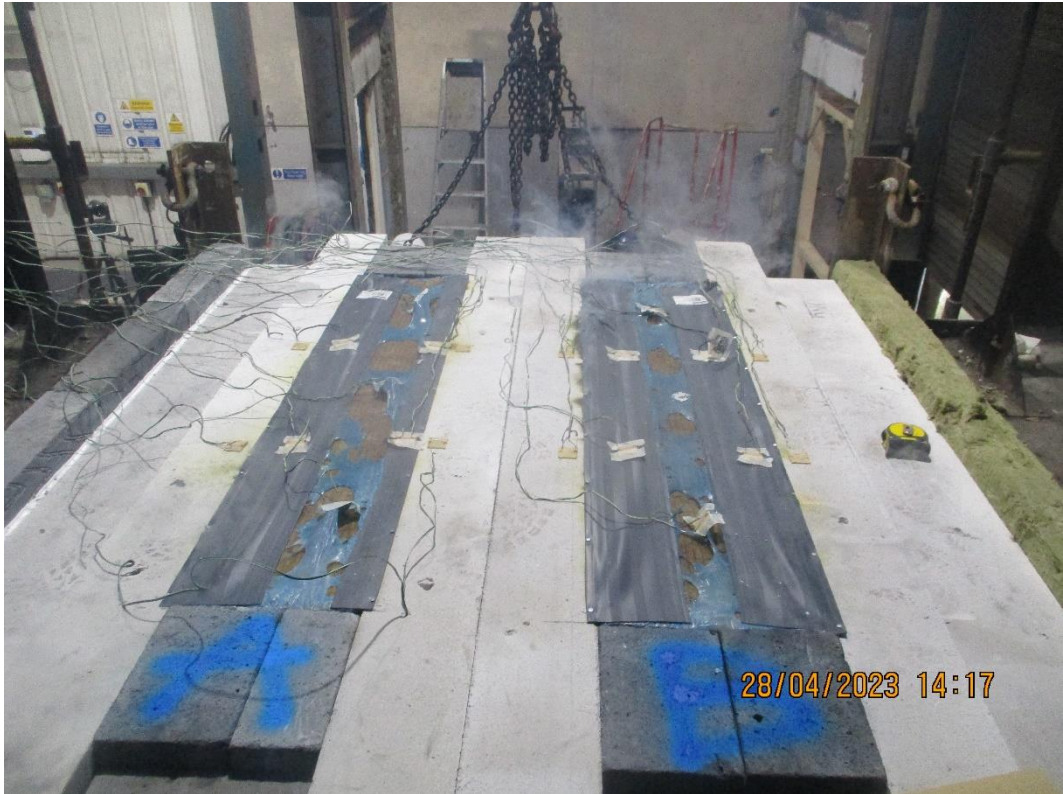
The unexposed horizontal face after a test duration of 15 minutes

15	40	A and B. There is an increase in smoke issuing and discolouration.
18	00	C and D. The plastic edging is melting.
20	00	A and B. There is no change visible.
23	40	D. There is glow visible at the bottom left corner.
24	56	D. A cotton pad test was performed at the bottom left corner which did not result in the ignition of the cotton pad. No Failure.
25	00	A and B. There is no change visible.
28	08	D. A cotton pad test was performed at the bottom left corner which did not result in the ignition of the cotton pad. No Failure.
28	40	A and B. There is an increase in discolouration.
29	25	D. A cotton pad test was performed at the bottom left corner which did not result in the ignition of the cotton pad. No Failure.
30	34	B. There is glow visible at the top.
31	28	D. A cotton pad test was performed at the bottom left corner which did not result in the ignition of the cotton pad. No Failure.
32	10	B. The top has fallen in therefore constituting integrity failure by virtue of visual gap gauge.

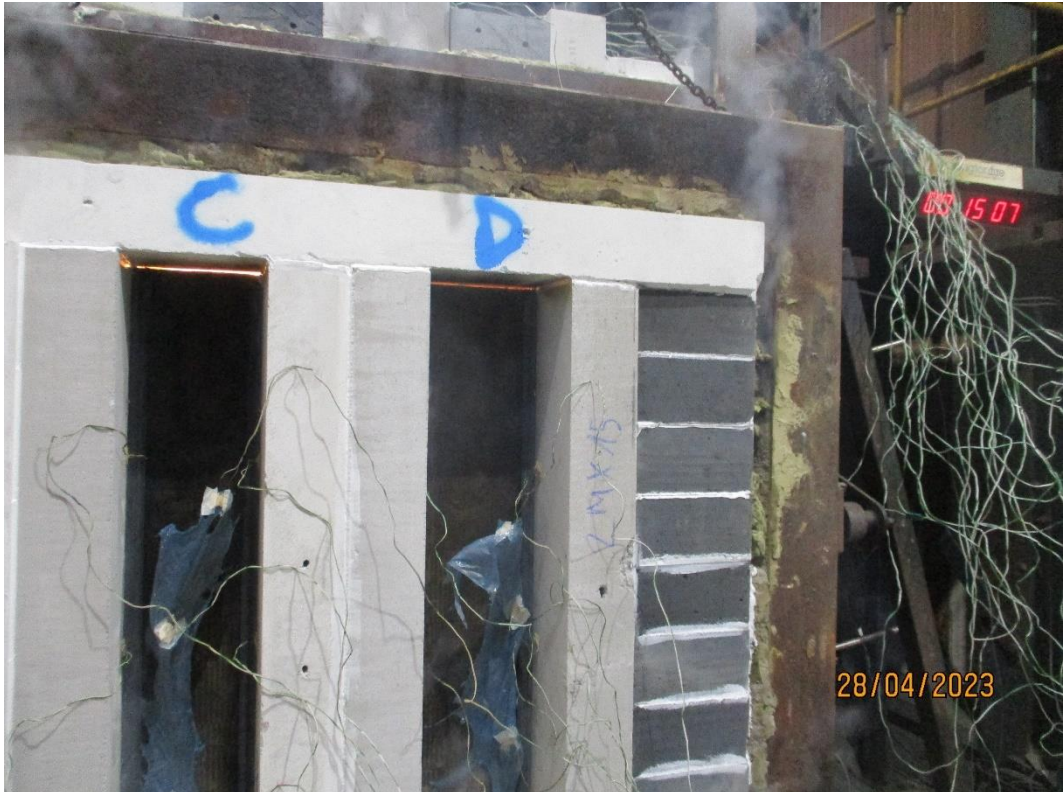
The unexposed vertical face after a test duration of 15 minutes 7 seconds

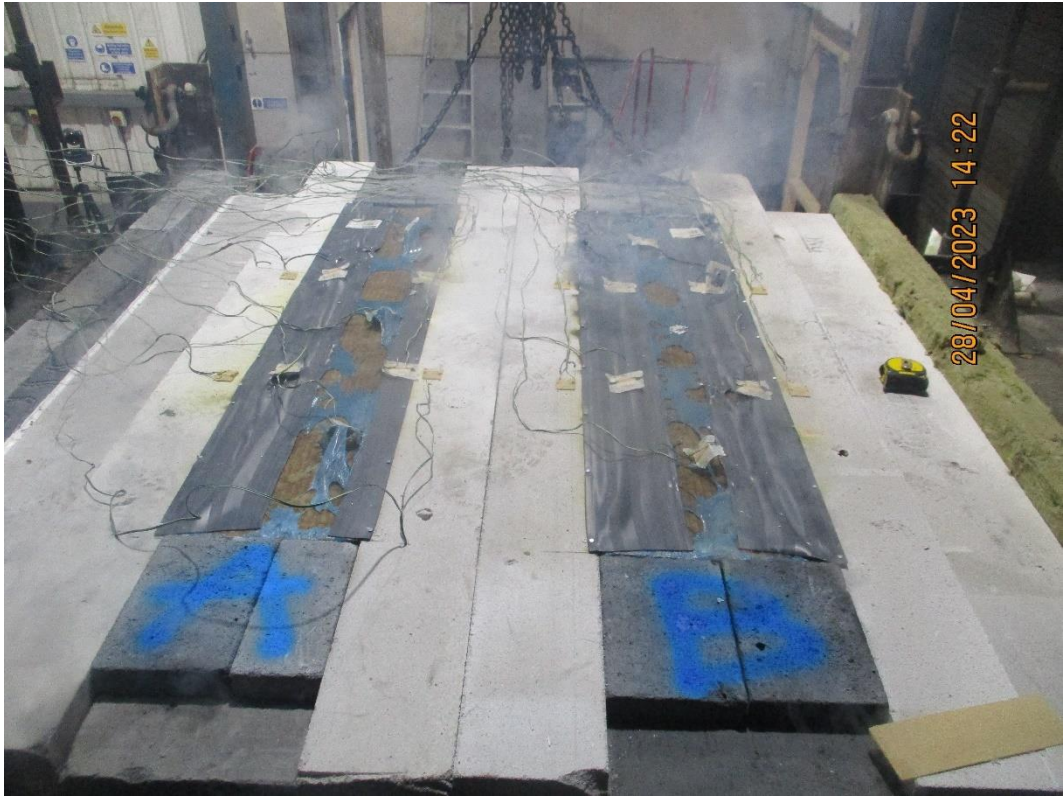
The unexposed horizontal face after a test duration of 20 minutes

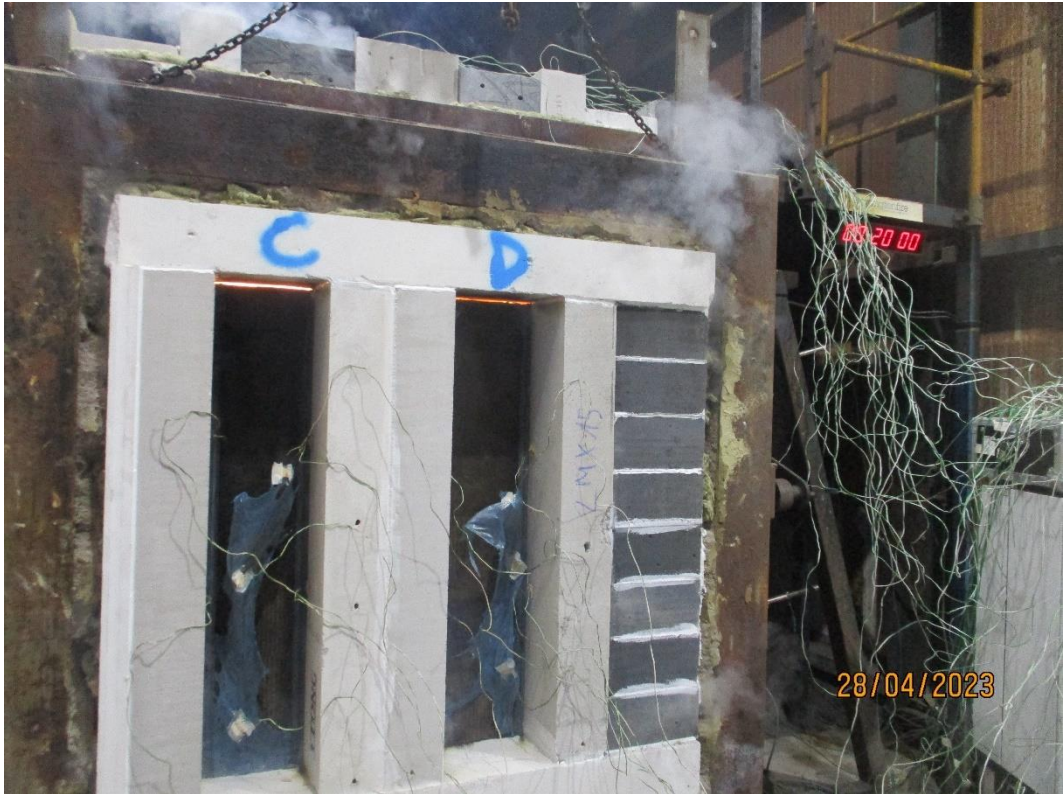
The unexposed face after a test duration of 20 minutes

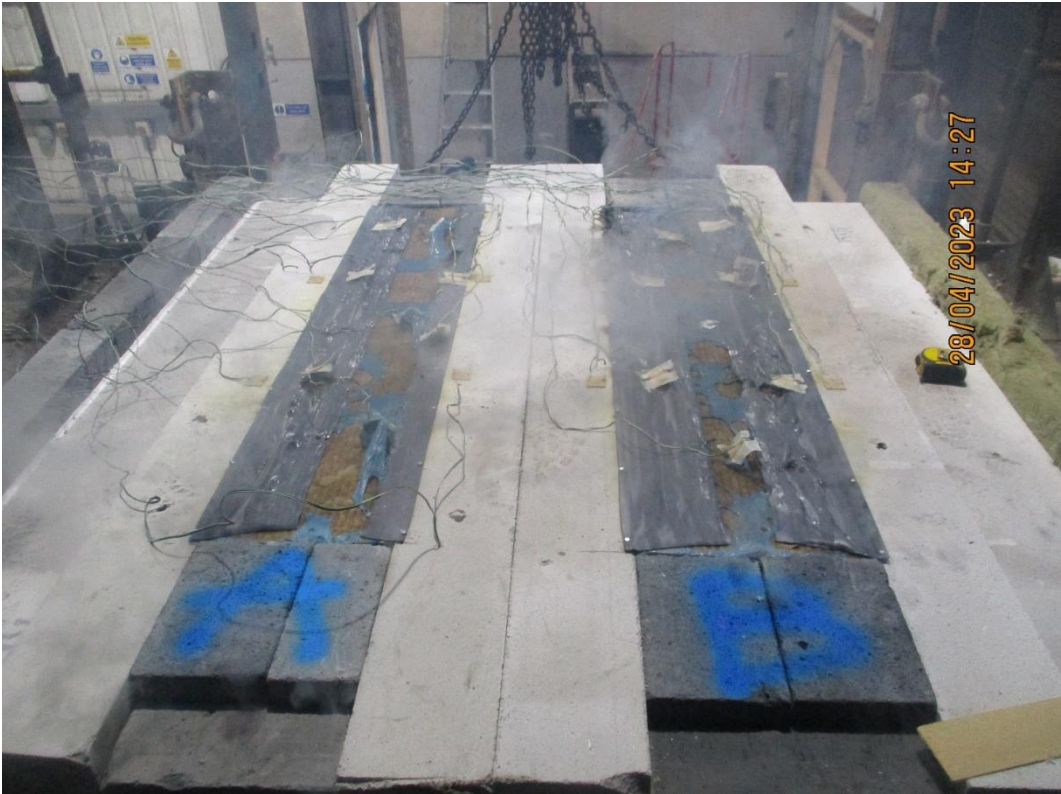
The unexposed horizontal face after a test duration of 25 minutes

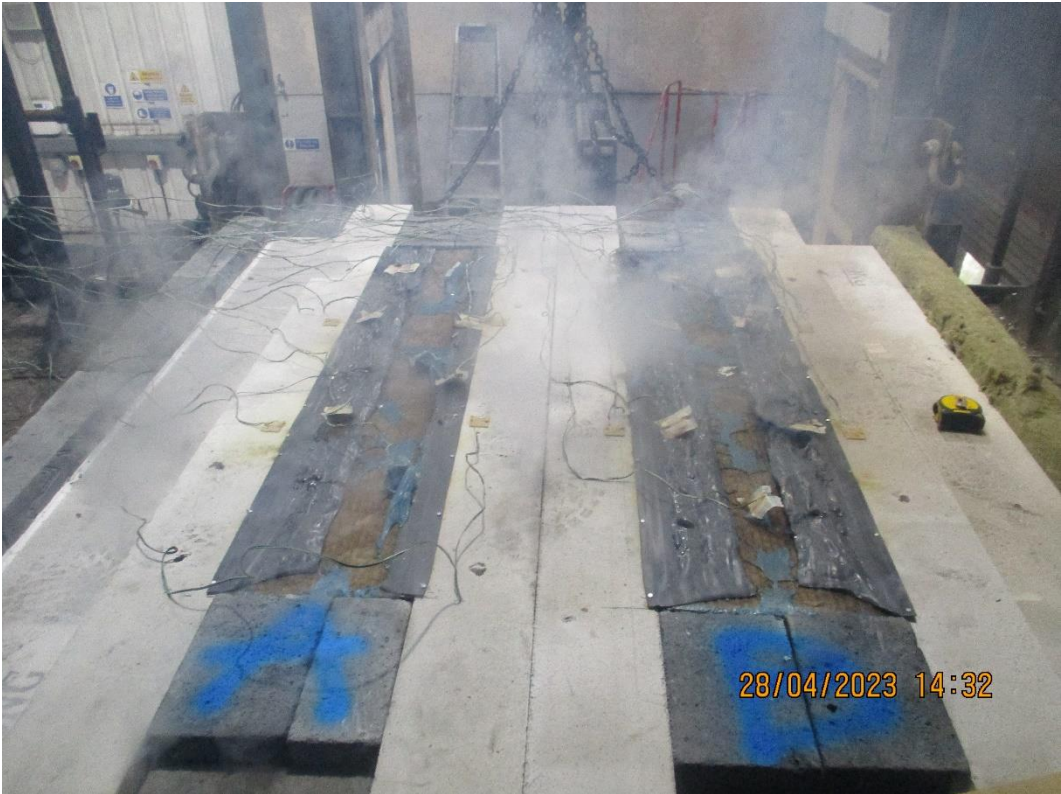
The unexposed horizontal face after a test duration of 30 minutes

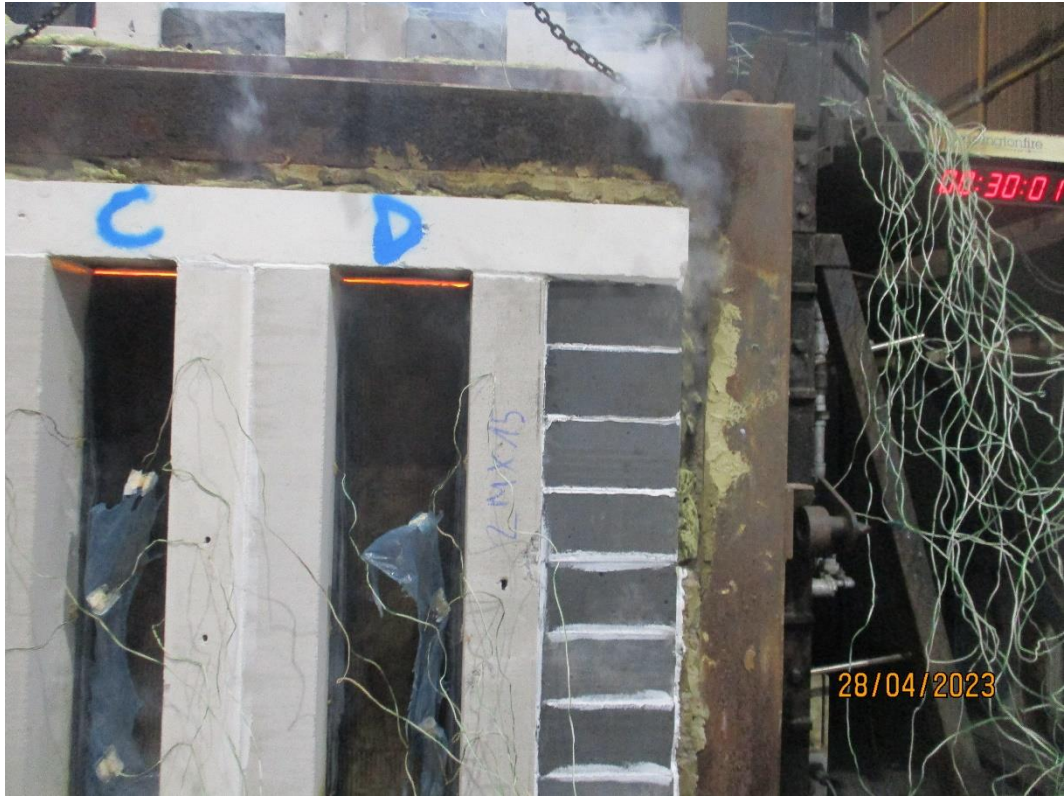
The unexposed vertical face after a test duration of 30 minutes 1 second

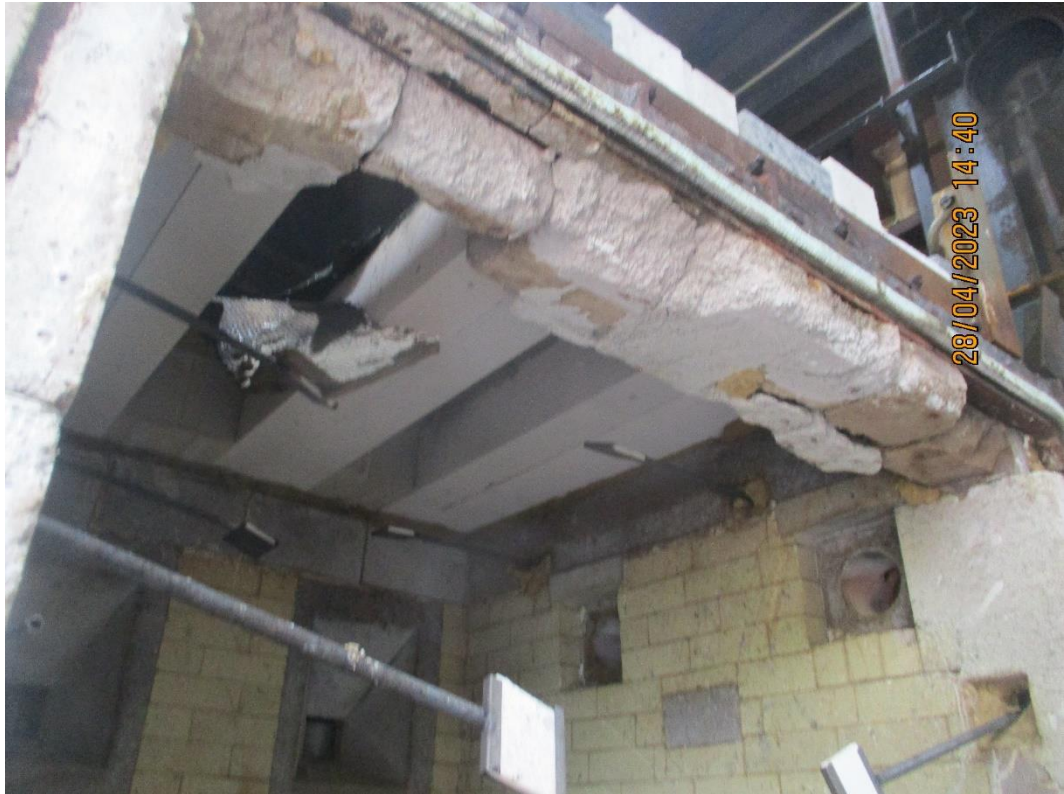
The exposed horizontal face after the completion of the test

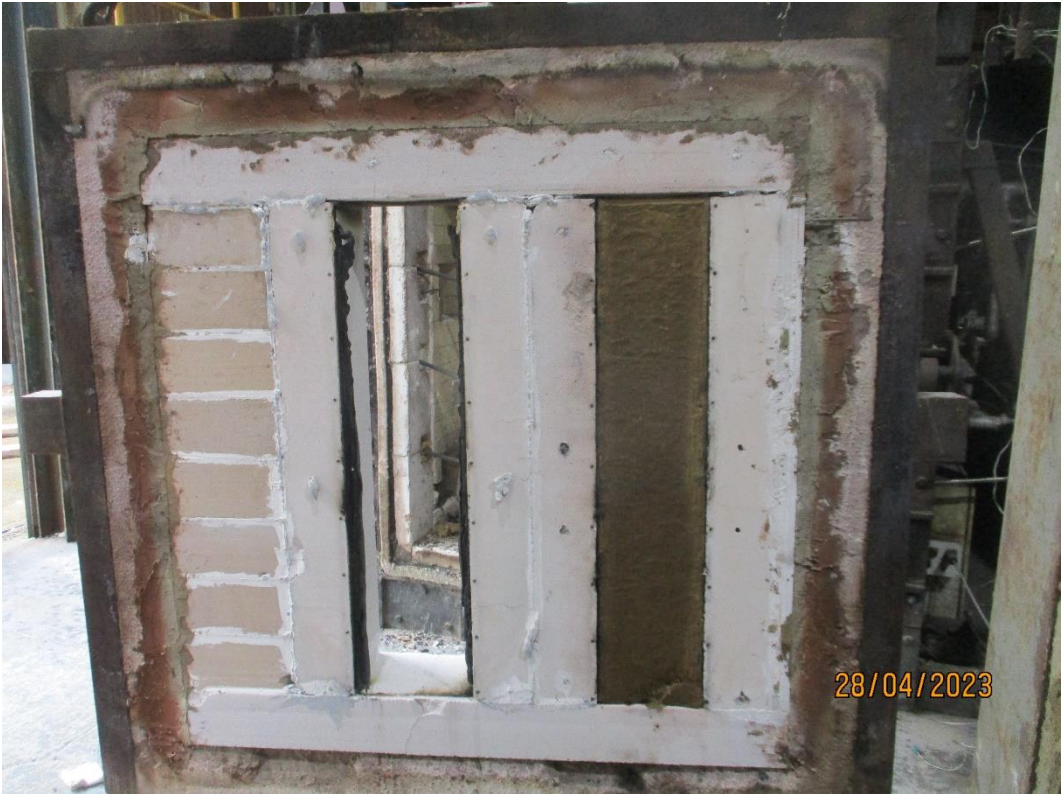
The exposed vertical face after the completion of the test

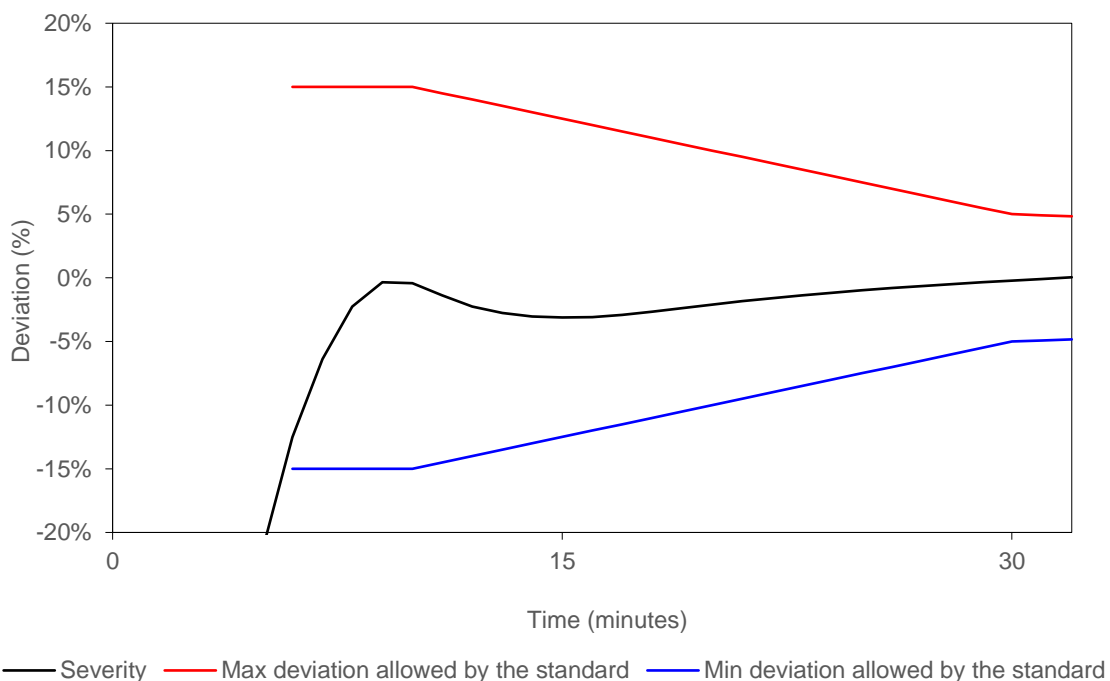
Graph showing percentage temperature deviation, together with the associated tolerances specified in BS EN 1363-1: 2020

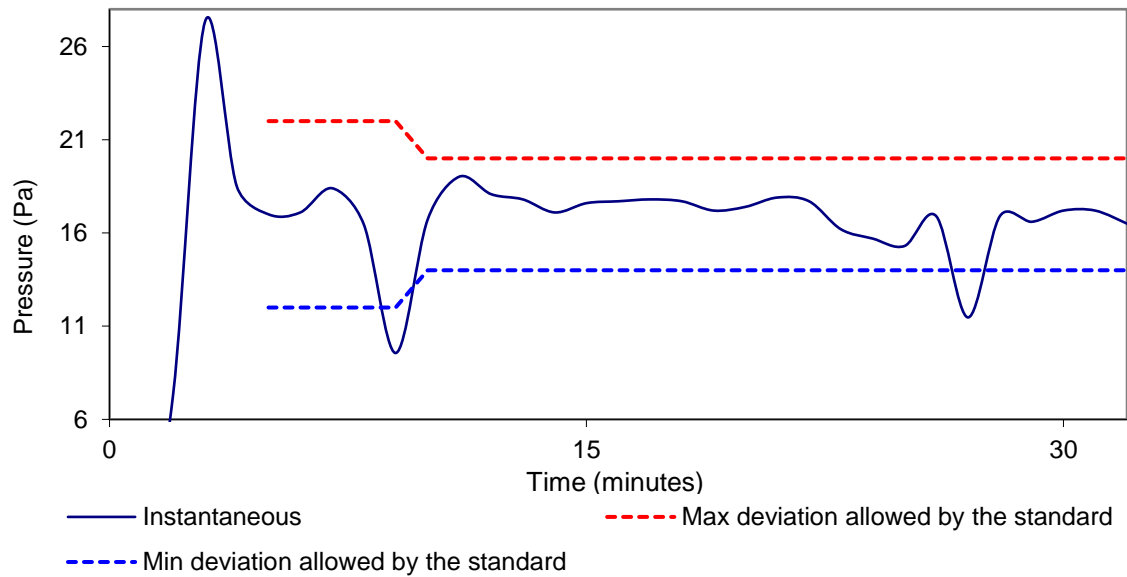
Graph showing recorded furnace pressure at 1m from the furnace floor

Due to necessary adjustments of the gas and air input to control the furnace, pressures outside the specified tolerances were recorded sporadically at short intervals. As the pressure fluctuations recorded at those intervals did not represent the pressure conditions throughout the test, their effect on the test results can be disregarded.
