The Fire Resistance
Performance Of Three
Specimens Of Wall
Mounted And One
Specimens Of Floor
Mounted Linear Gap
Sealing Systems, When
Tested In General
Accordance With
EN 1366-4:2006+A1:2010

431809/R

Timloc Building Products

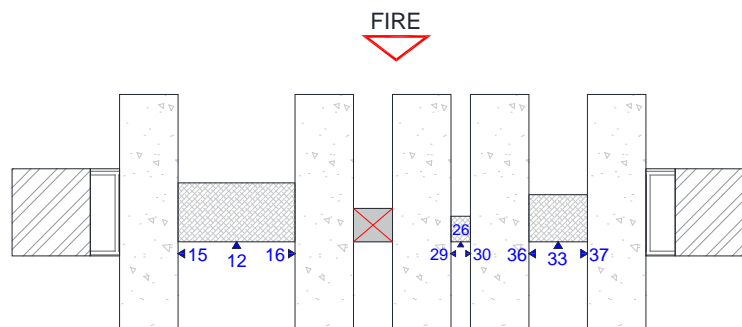
Figure 1- General Elevation of Wall Construction

■/▼ Positions of surface thermocouples

GENERAL ELEVATION OF WALL TEST CONSTRUCTION
SHOWING THERMOCOUPLE LOCATIONS

HORIZONTAL SECTION THROUGH WALL TEST CONSTRUCTION
SHOWING THERMOCOUPLE LOCATIONS

Thermocouples	<p>Thermocouples were provided to monitor the unexposed surface of the specimens. The output of all instrumentation was recorded at no less than one minute intervals. The locations and reference numbers of the various unexposed surface thermocouples are shown in Figures 1 and 6.</p>
Furnace Pressure	<p>After the first five minutes of testing and for the remainder of the test, the furnace atmospheric pressure was controlled so that it complied with the requirements of BS EN 1363-1: 2020, clause 5.2.1 The calculated pressure differential relative to the laboratory atmosphere at mid height of wall specimens was 15 (\pm 5) and at position 100 mm below the underside of the floor assembly the differential pressure was calculated to be 20 (\pm 5) Pa between 5 and 10 minutes and (\pm 3) Pa respectively thereafter.</p>

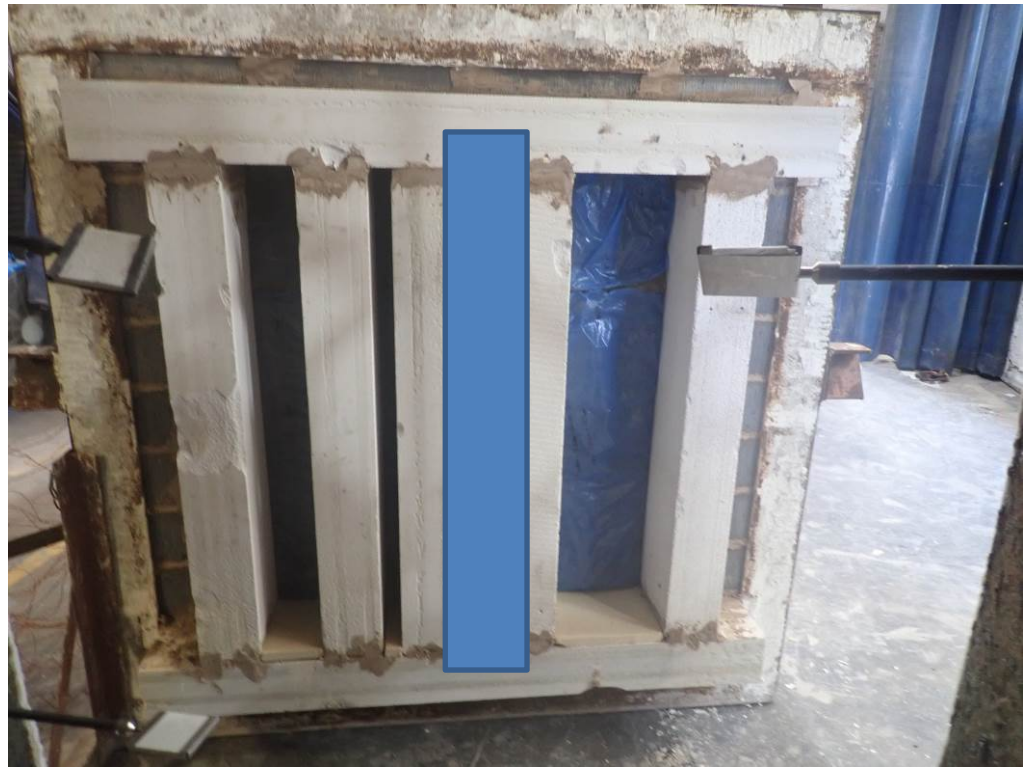
The exposed face of the wall assembly prior to testing

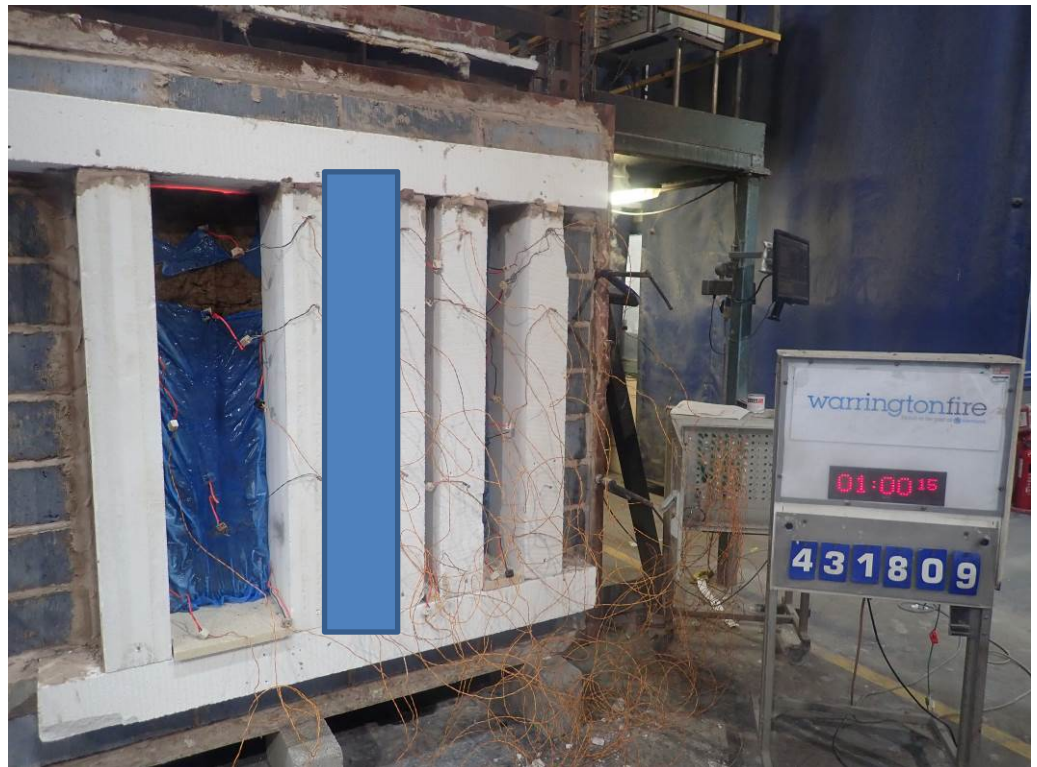
The unexposed face of the wall assembly after a test duration of 60 minutes

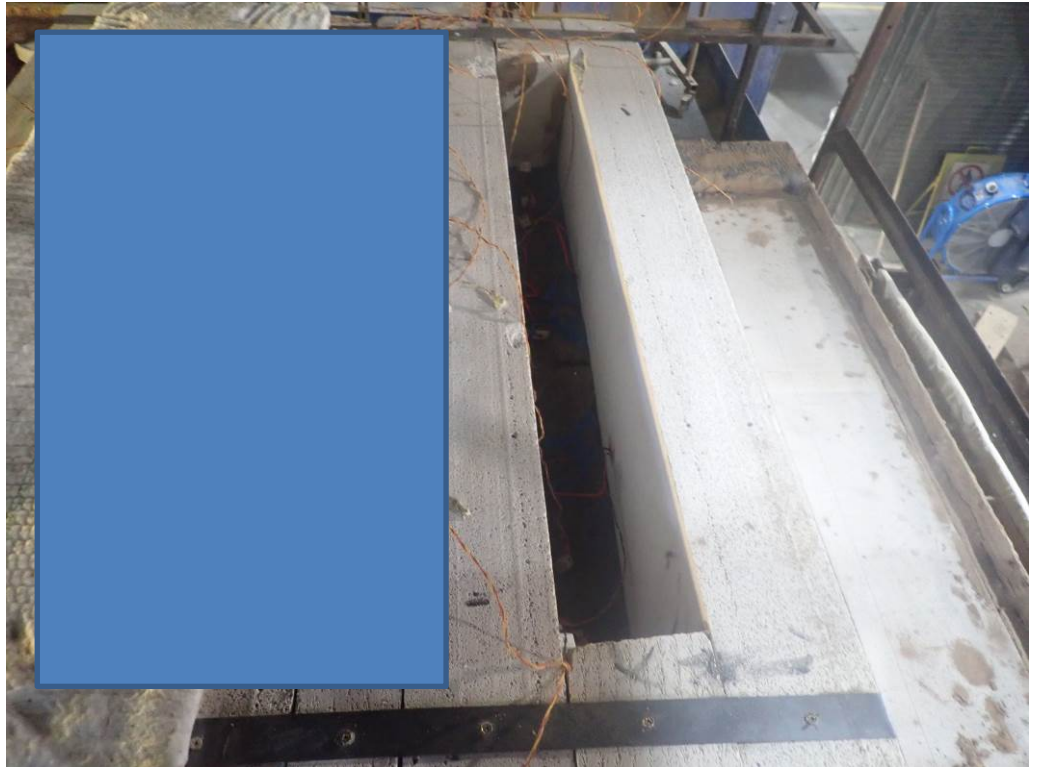
The unexposed face of the floor assembly after a test duration of 60 minutes

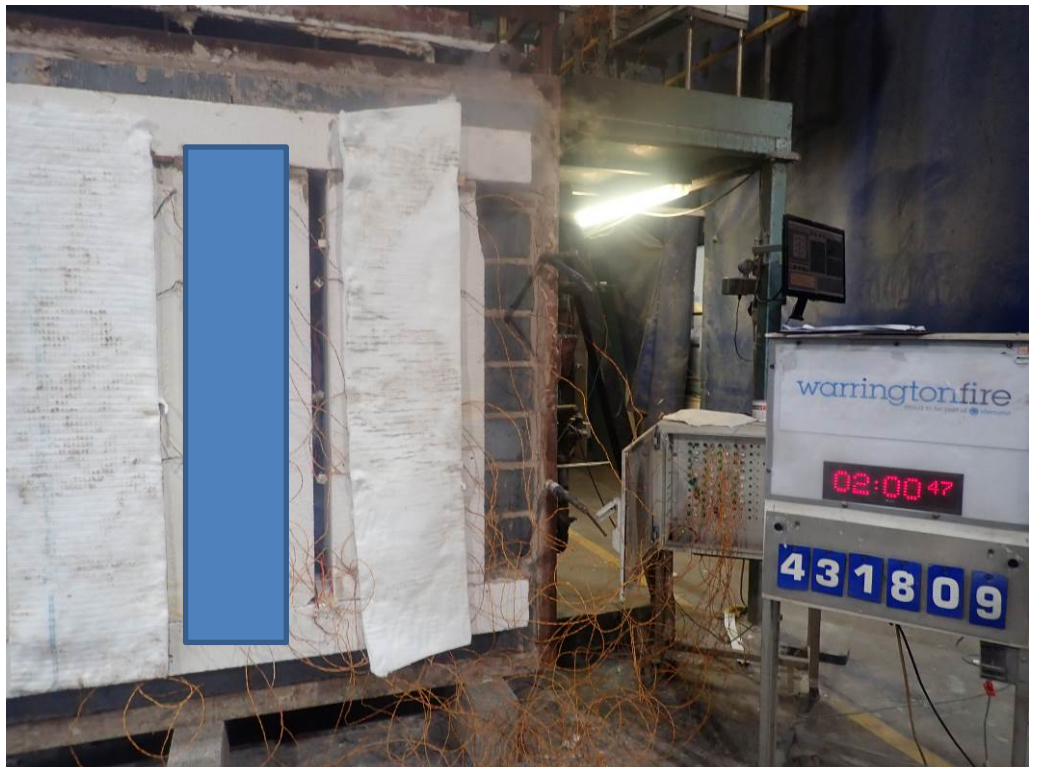
The unexposed face of the wall assembly after a test duration of 120 minutes

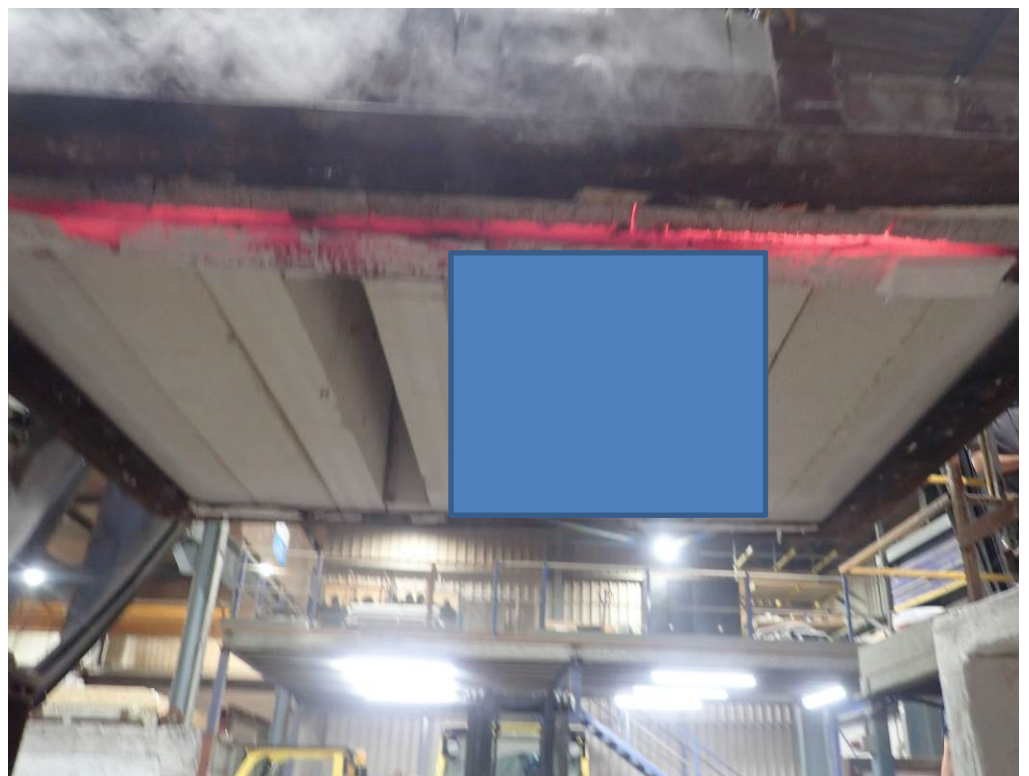
The exposed face of the floor assembly immediately after the test
