The Fire Resistance Performance Of 2 Specimens of Wall Mounted and 2 Specimens Of Floor Mounted Cavity Barrier Systems, When Tested In Accordance With EN 1366-4:2021

545648/R

Timloc Building Products

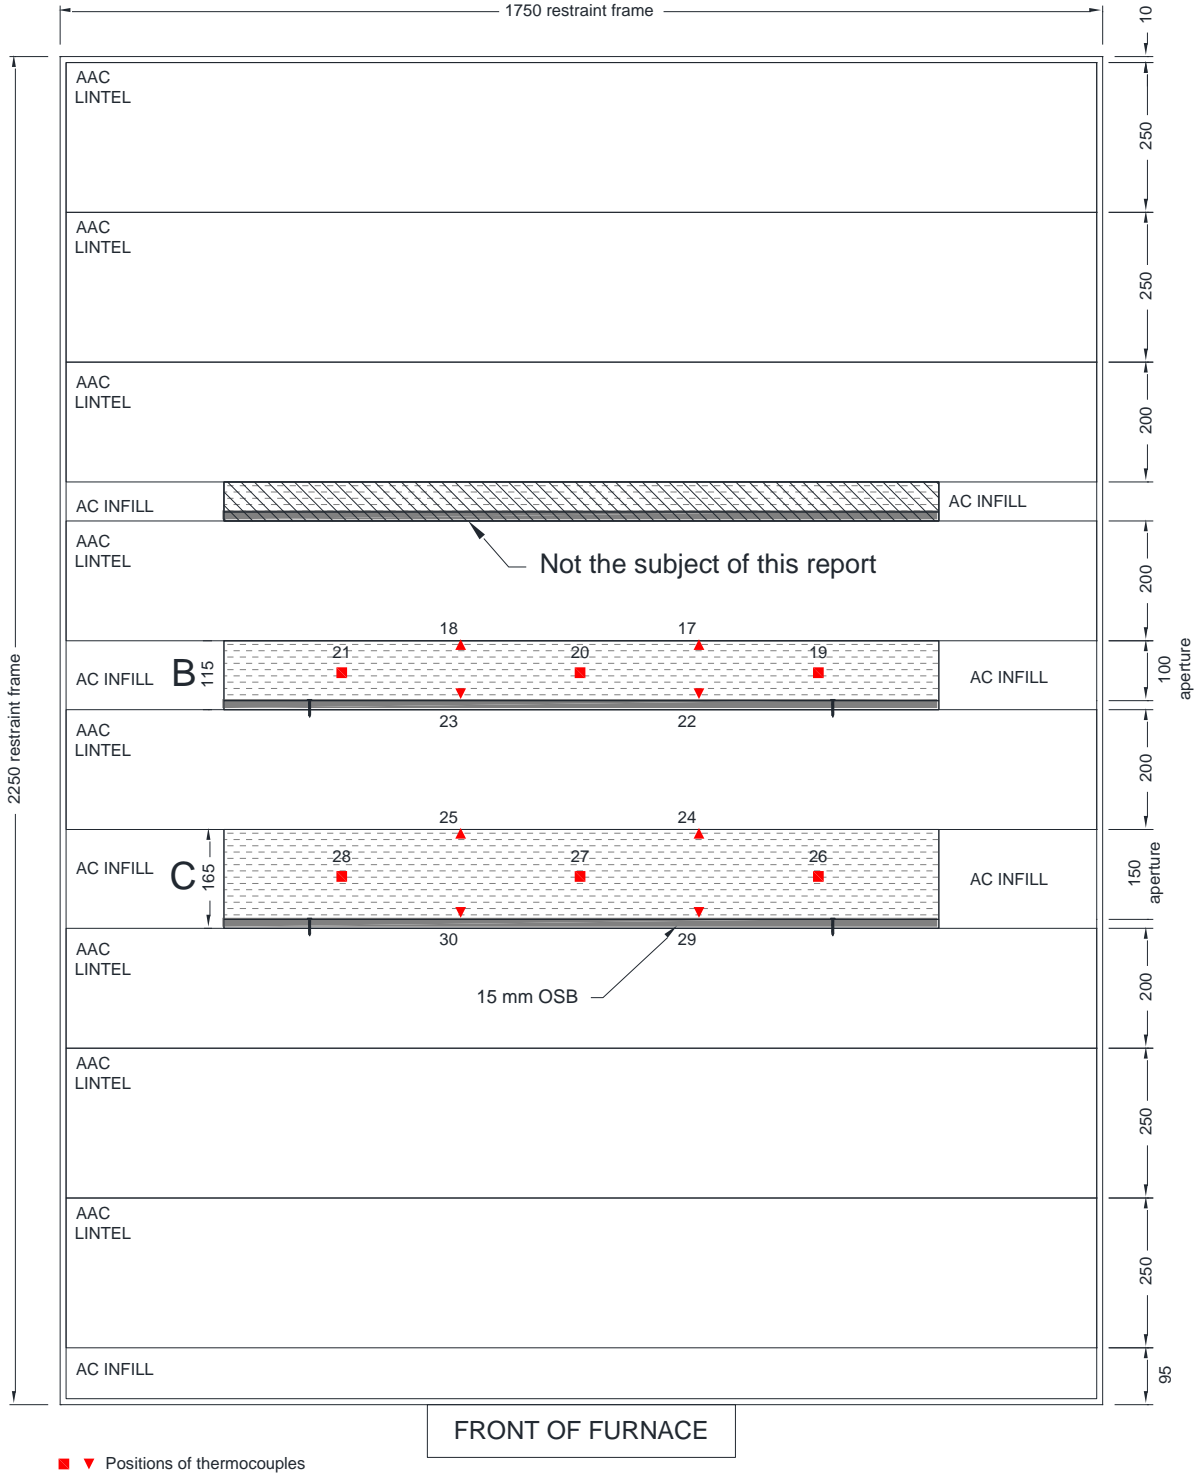
Figure 1. General Plan of unexposed face showing thermocouple positions

GENERAL PLAN OF UNEXPOSED FACE SHOWING THERMOCOUPLE POSITIONS

Thermocouples	<p>Thermocouples were provided to monitor the unexposed surface of the specimens. The output of all instrumentation was recorded at no less than one minute intervals. The locations and reference numbers of the various unexposed surface thermocouples are shown in Figures 1 and 4.</p>
Furnace Pressure	<p>The requirements of BS EN 1363-1: 2020, clause 5.2 could not be satisfied due to simultaneous testing of wall and floor specimens. The floor specimens were tested under more onerous conditions, at position 100 mm below the underside of the floor assembly the differential pressure was calculated to be 25 (\pm 5) Pa between 5 and 10 minutes and 25 (\pm 3) Pa respectively thereafter. The wall specimens satisfied the requirements of BS EN 1363-1: 2020, clause 5.2. The calculated pressure differential relative to the laboratory atmosphere at mid height of the lowest mounted wall specimens was 15 (\pm 5) Pa between 5 and 10 minutes and 15 (\pm 3) Pa respectively thereafter.</p>

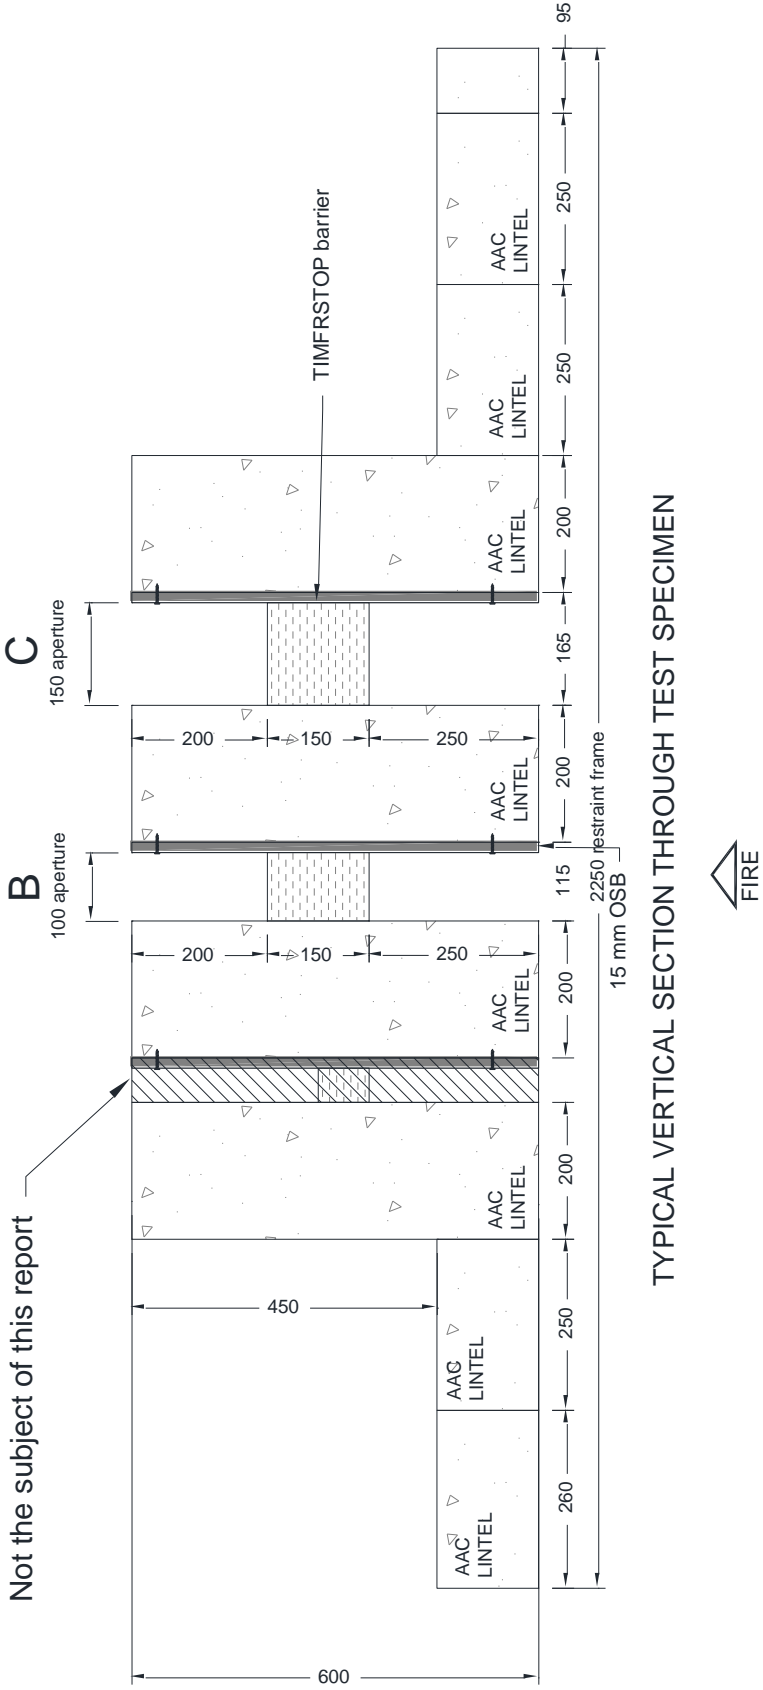
Figure 2. Typical vertical section through test specimen

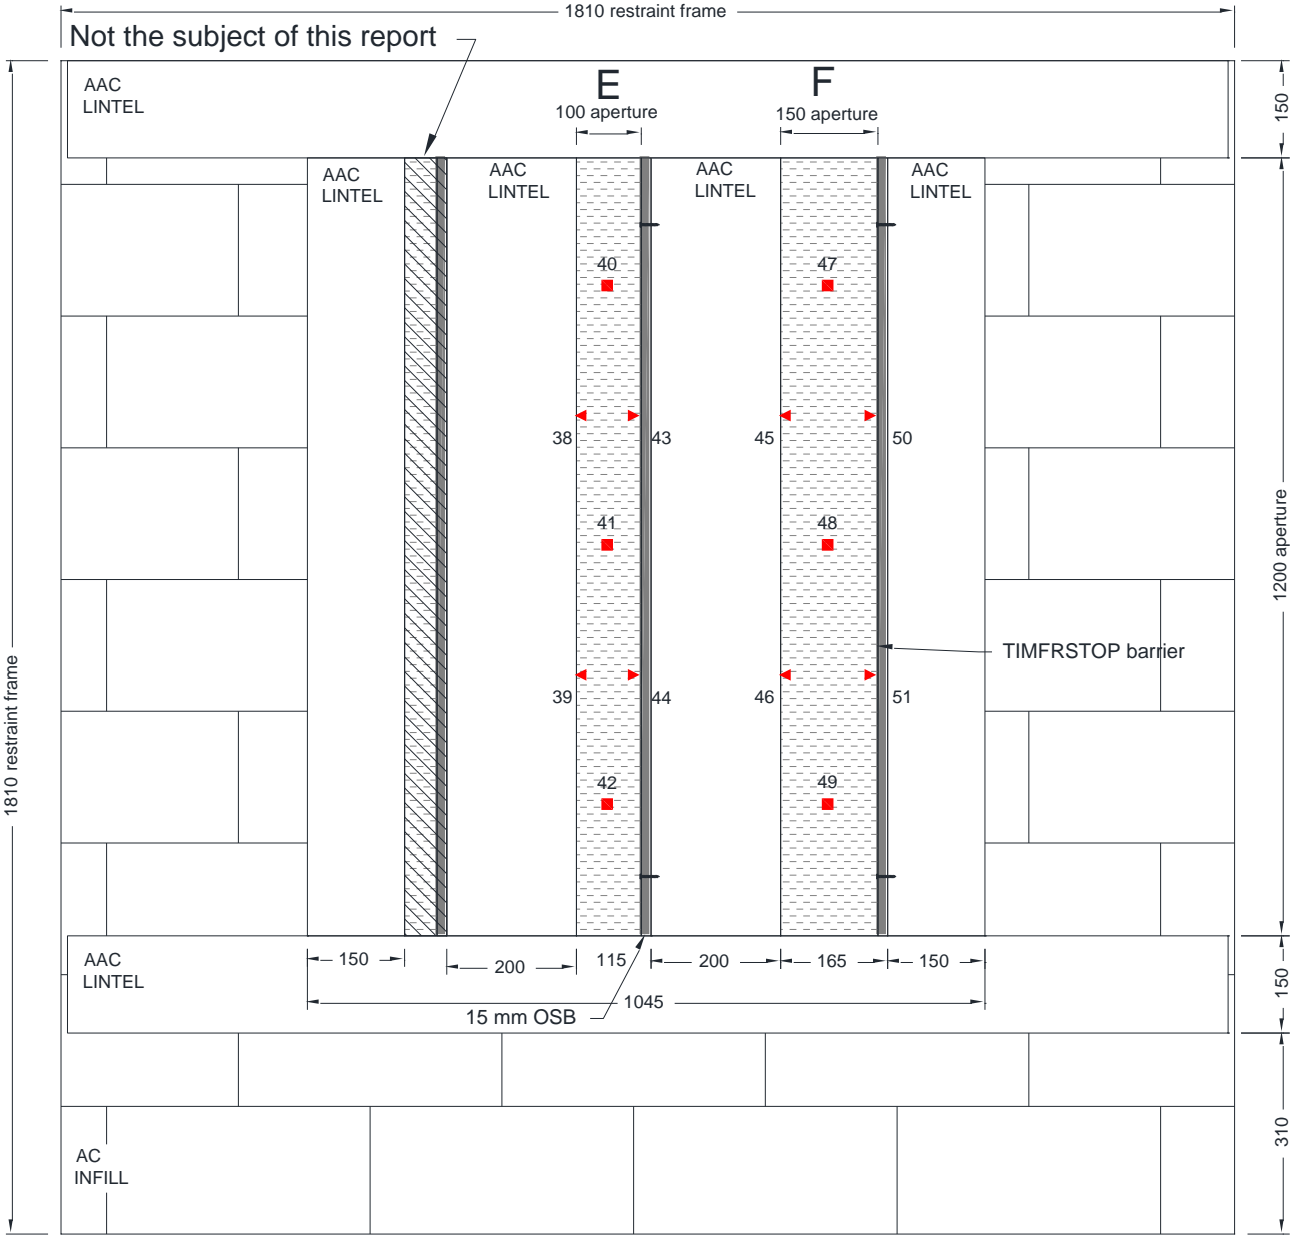
Figure 3. General elevation of unexposed face showing thermocouple positions

■ ▼ Positions of thermocouples

GENERAL ELEVATION OF UNEXPOSED FACE SHOWING THERMOCOUPLE POSITIONS

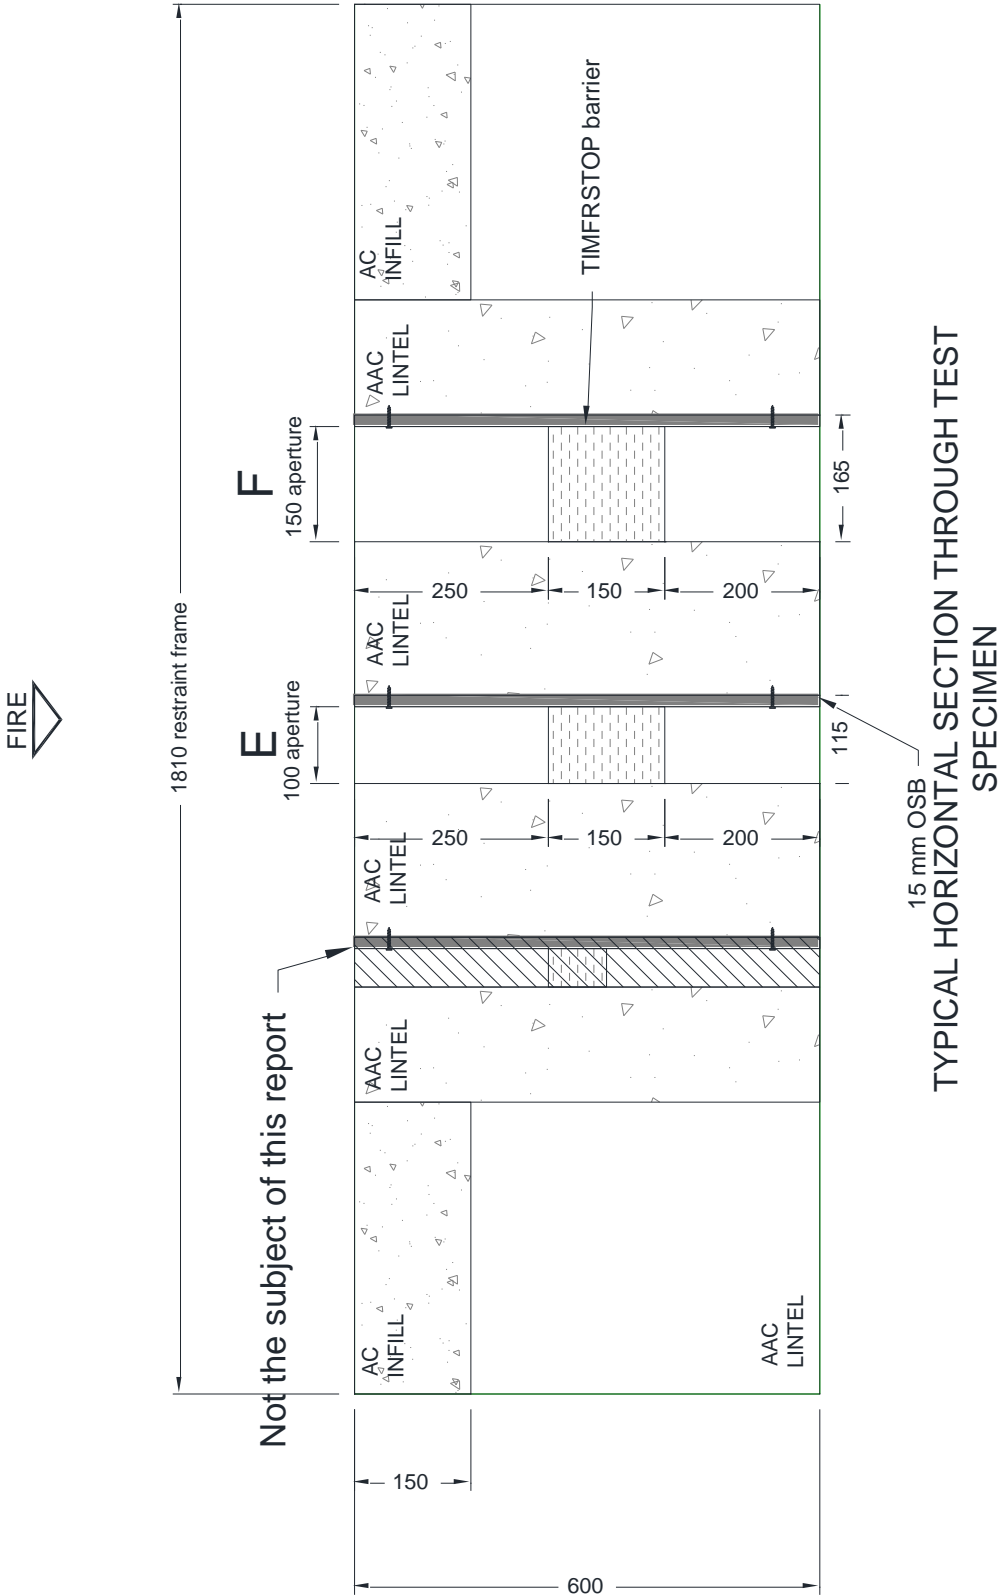
Figure 4. Typical horizontal section through test specimen

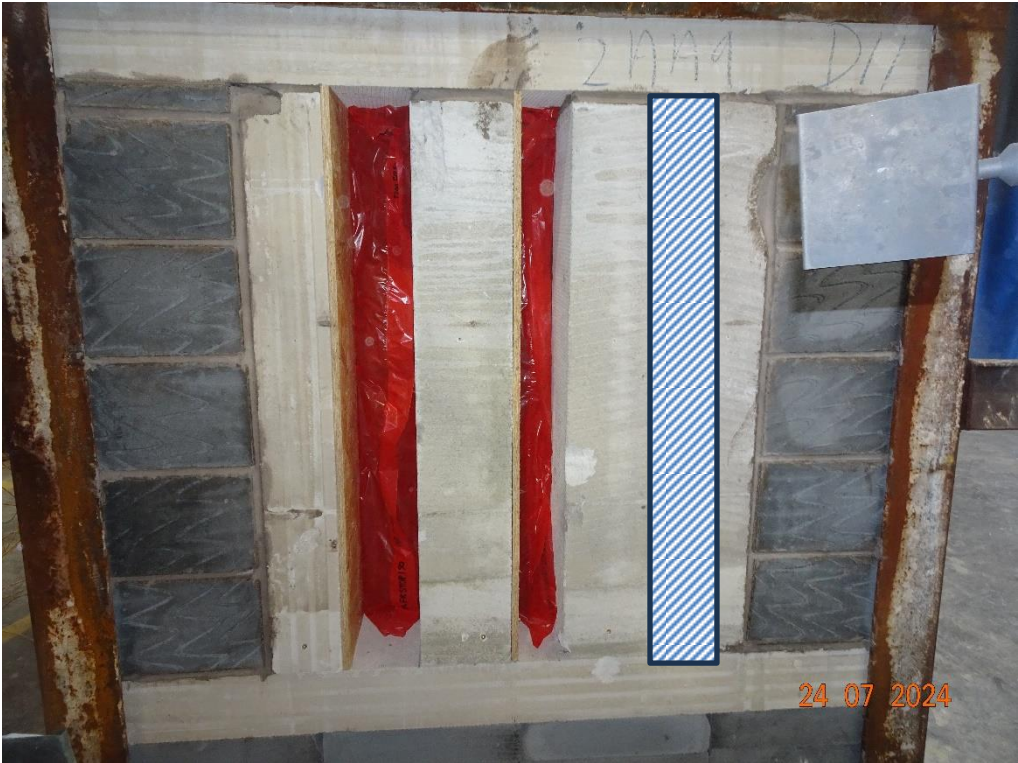
The exposed face of the wall assembly prior to testing

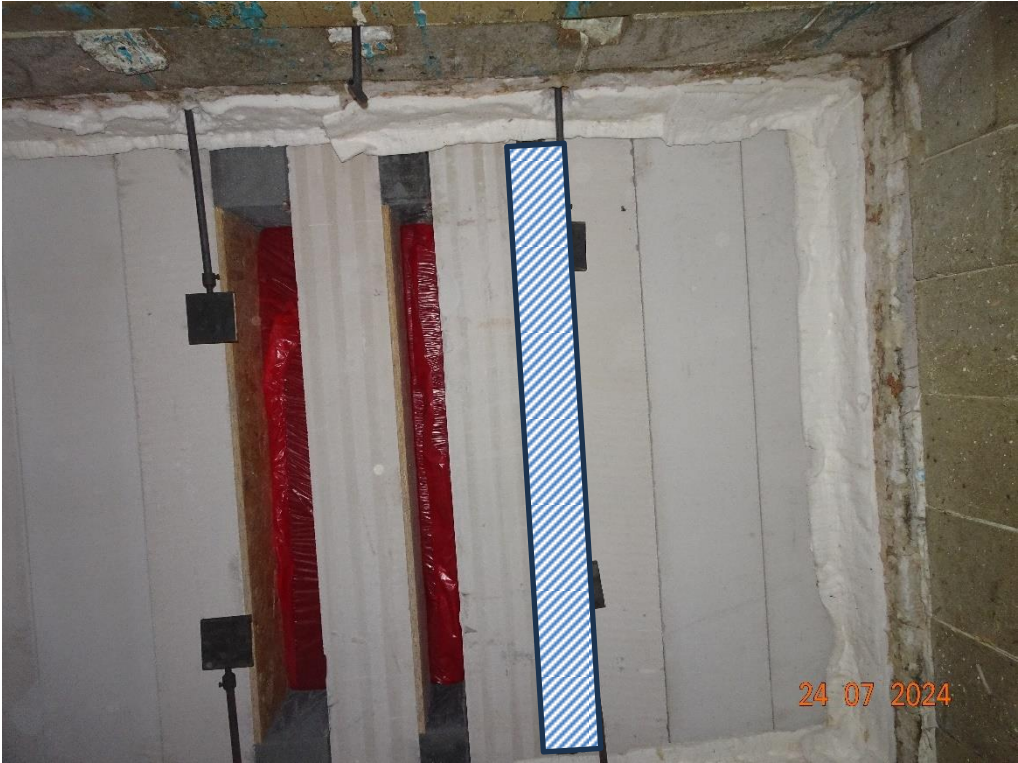
The exposed face of the floor assembly prior to testing

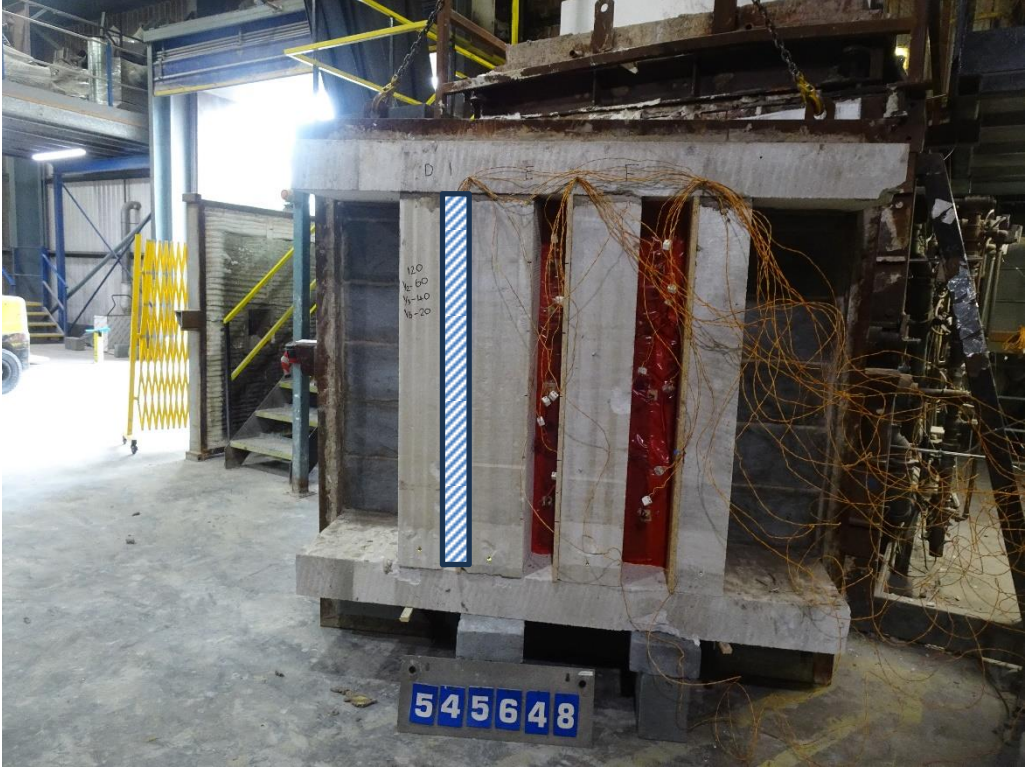
The unexposed face of the wall assembly prior to the start of the test

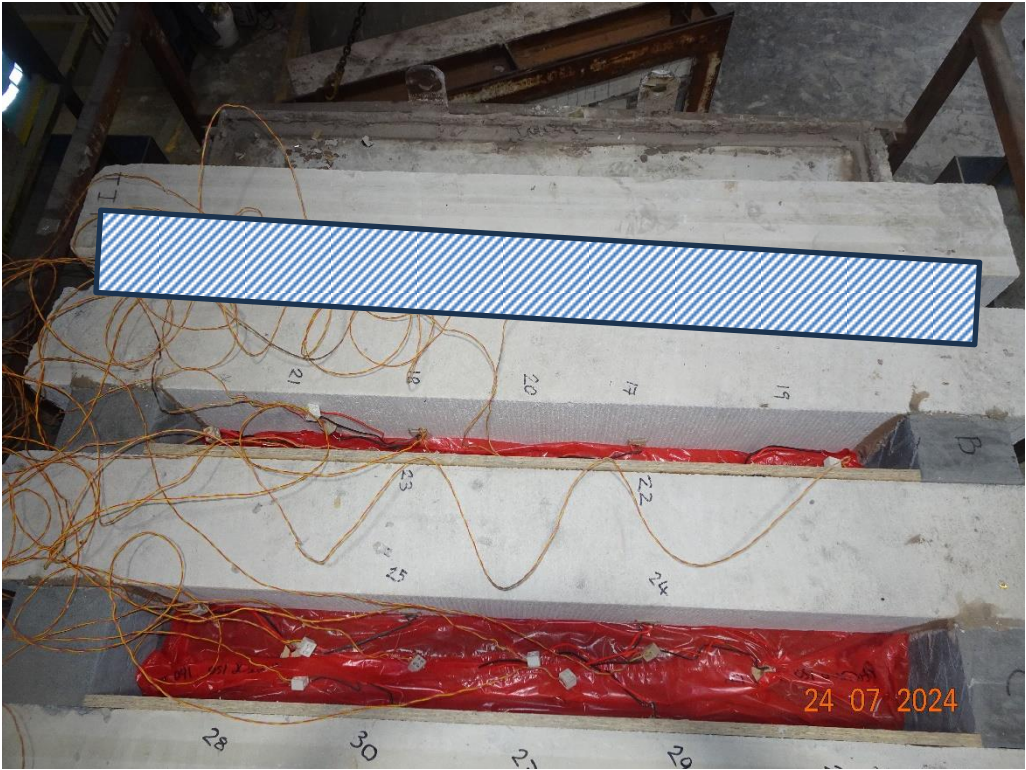
The unexposed face of the floor assembly prior to the start of the test

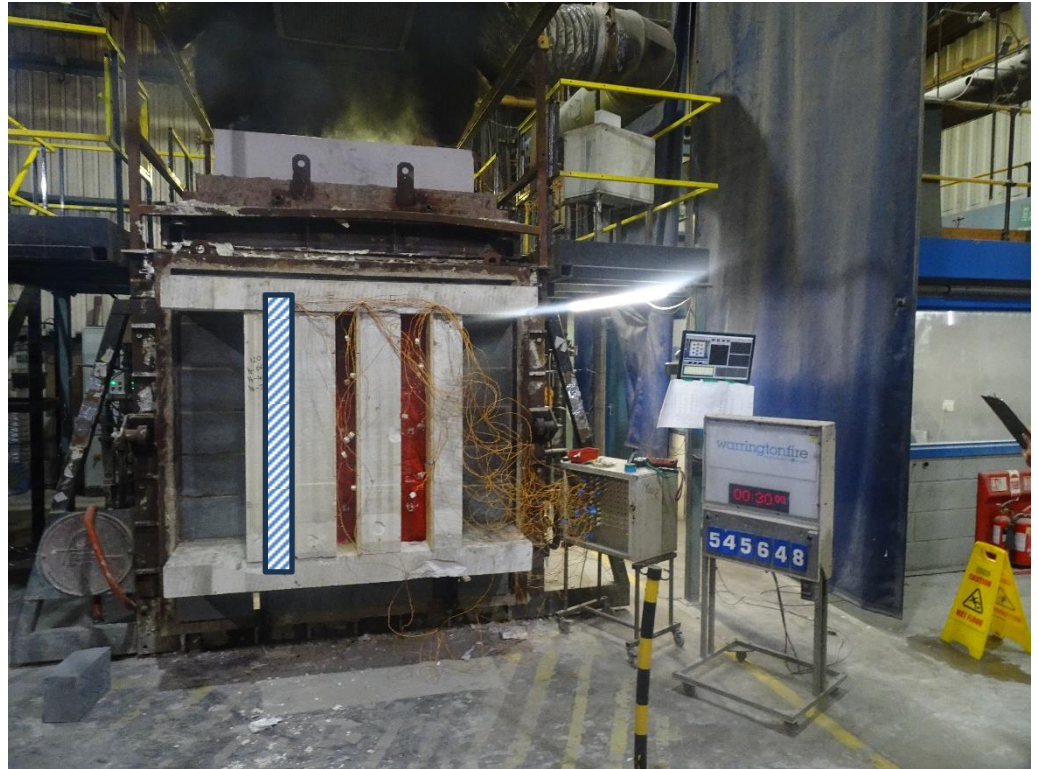
The unexposed face of the wall assembly after a test duration of 30 minutes

Time		All observations are from the unexposed face unless noted otherwise.
mins	secs	
00	00	The Test Commences.
05	30	Smoke release from the top of Specimen E at the AAC and barrier interface.
07	20	Smoke release from Specimens B and C along the length of barrier and OSB interface.
12	50	Smoke release at the base of Specimen E along the length of the AAC and barrier interface.
22	20	Slight glowing visible at the head of both Specimen E, near the AAC and barrier interface. The glowing is not due to the OSB.
29	30	Darkening of OSB at the heads of Specimen E where the glowing is.
38	30	There is darkening at the OSB at the head of Specimen E near the glowing.
46	20	Considerable darkening of the OSB at the head of Specimen E.
47	10	Moisture is visible underneath the bag and above the Stone mineral wool.
62	10	Flaming and embers visible at the head of Specimen E, integrity failure is deemed to occur.
63	00	Glowing is visible at the head of Specimen F.

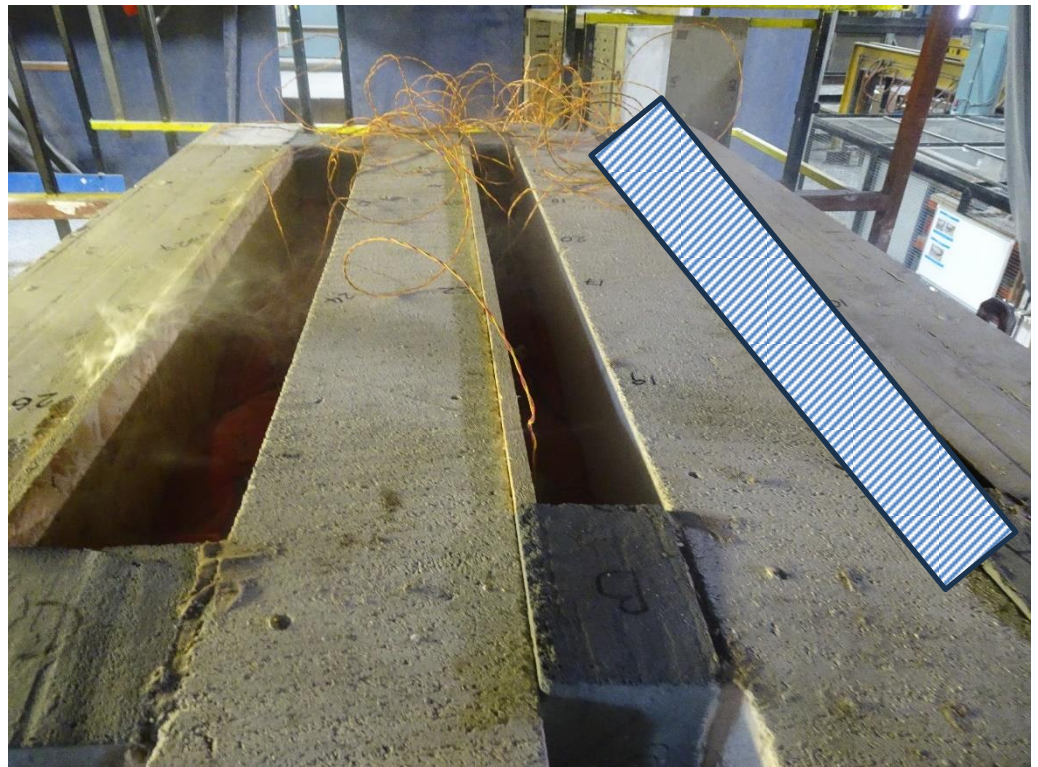
The unexposed face of the floor assembly after a test duration of 30 minutes

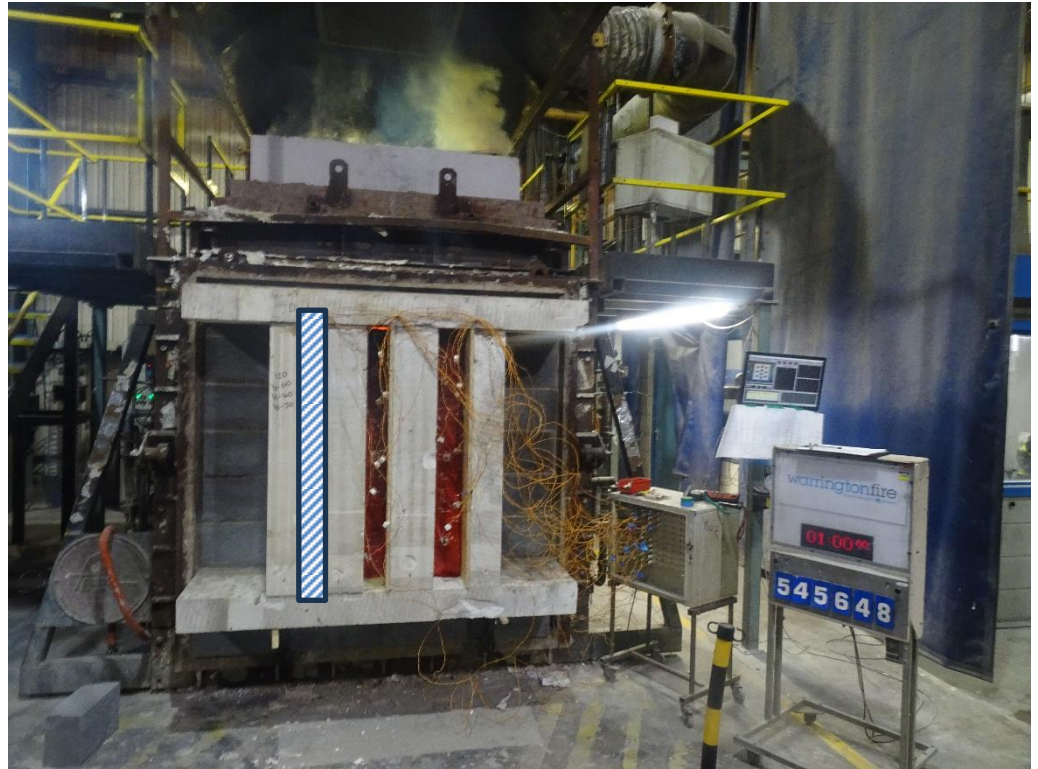
The unexposed face of the wall assembly after a test duration of 60 minutes

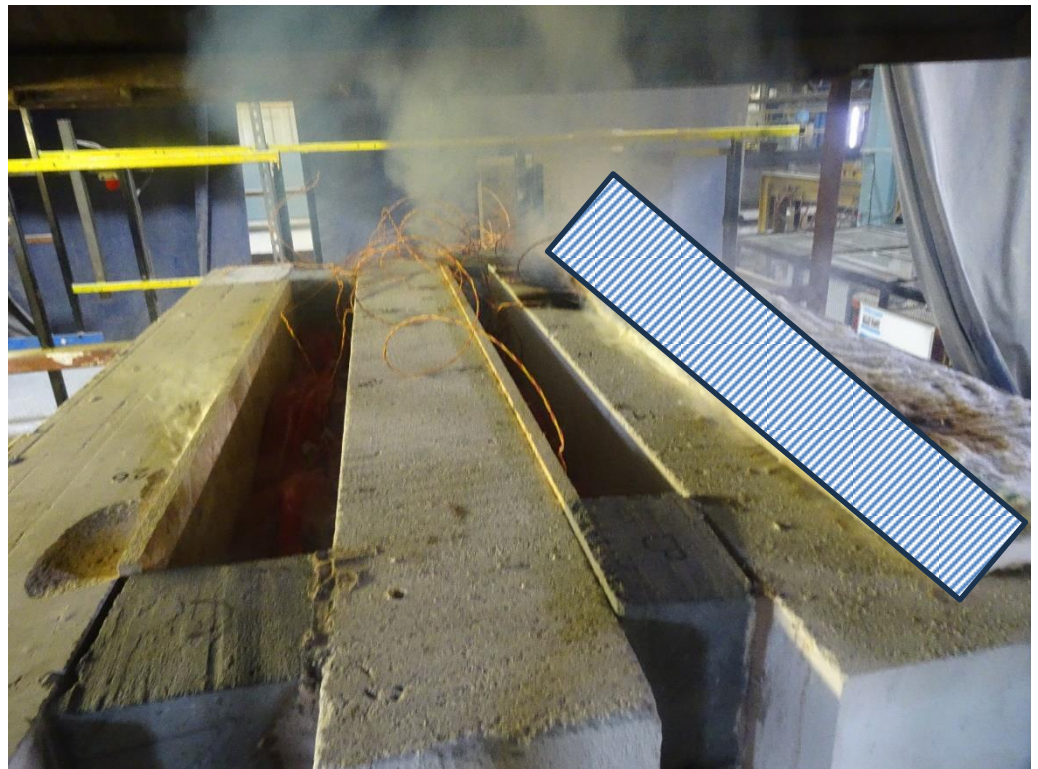
The unexposed face of the floor assembly after a test duration of 60 minutes

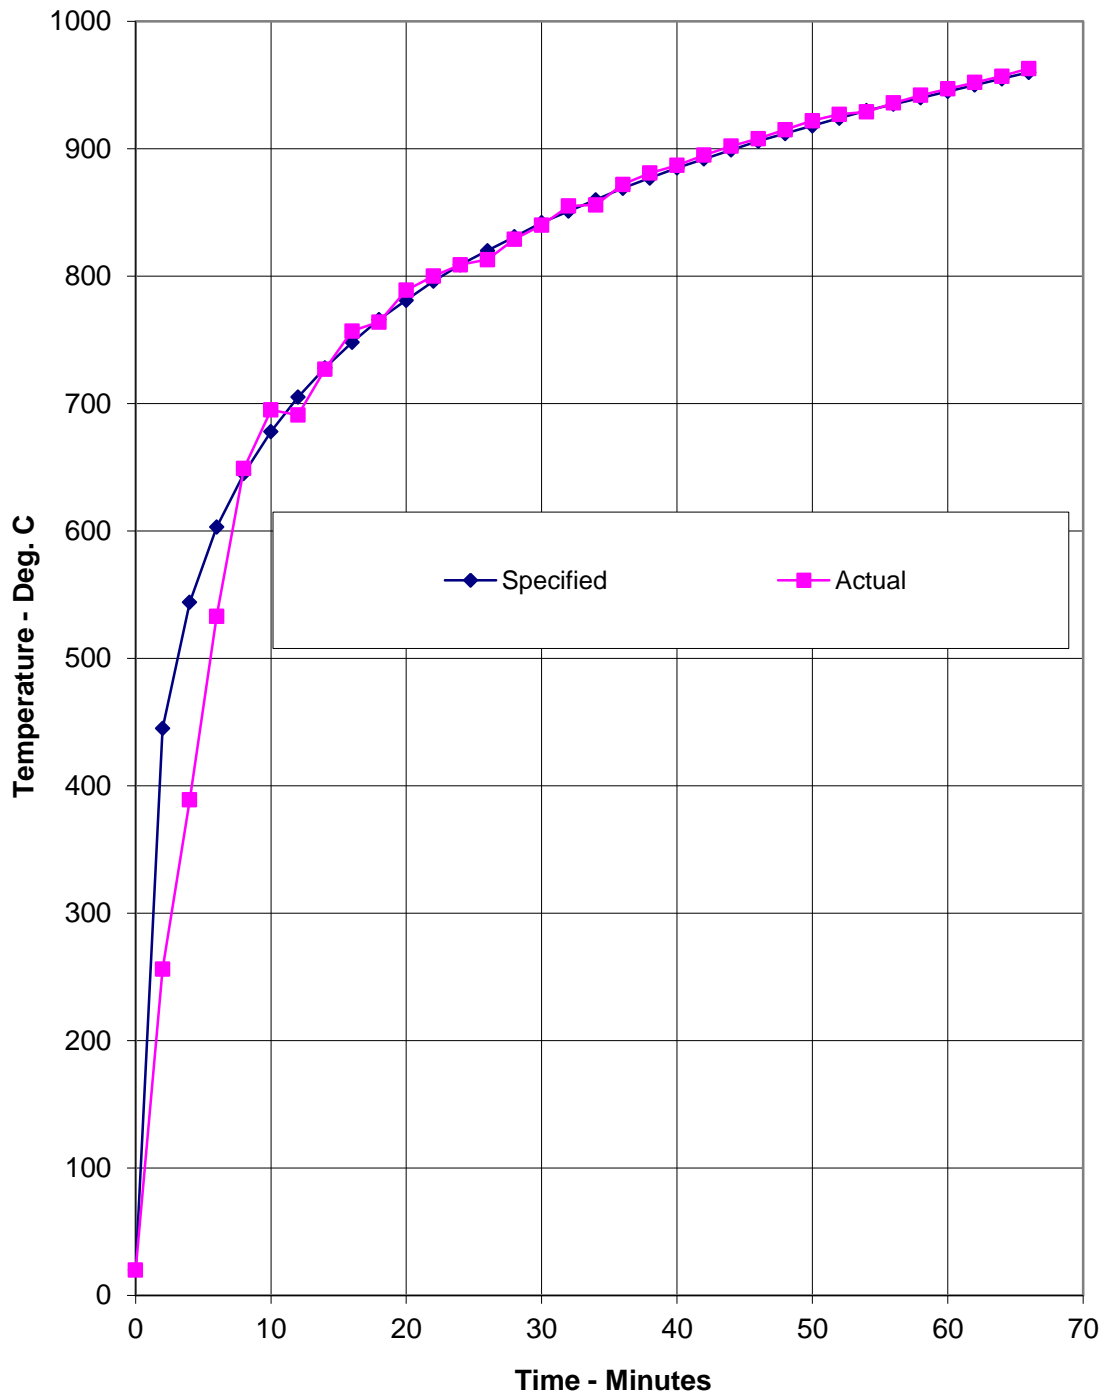
Graph showing mean furnace temperature, together with the temperature/time relationship specified in BS EN 1363-1: 2020

Mean furnace temperature, together with the temperature/time relationship specified in BS EN 1363-1: 2020

Time Mins	Specified Furnace Temperature Deg. C	Actual Furnace Temperature Deg. C
0	20	20
2	445	256
4	544	389
6	603	533
8	645	649
10	678	695
12	705	691
14	728	727
16	748	757
18	766	764
20	781	789
22	796	800
24	809	809
26	820	813
28	831	829
30	842	840
32	851	855
34	860	856
36	869	872
38	877	881
40	885	887
42	892	895
44	899	902
46	906	908
48	912	915
50	918	922
52	924	927
54	930	929
56	935	936
58	940	942
60	945	947
62	950	952
64	955	957
66	960	963

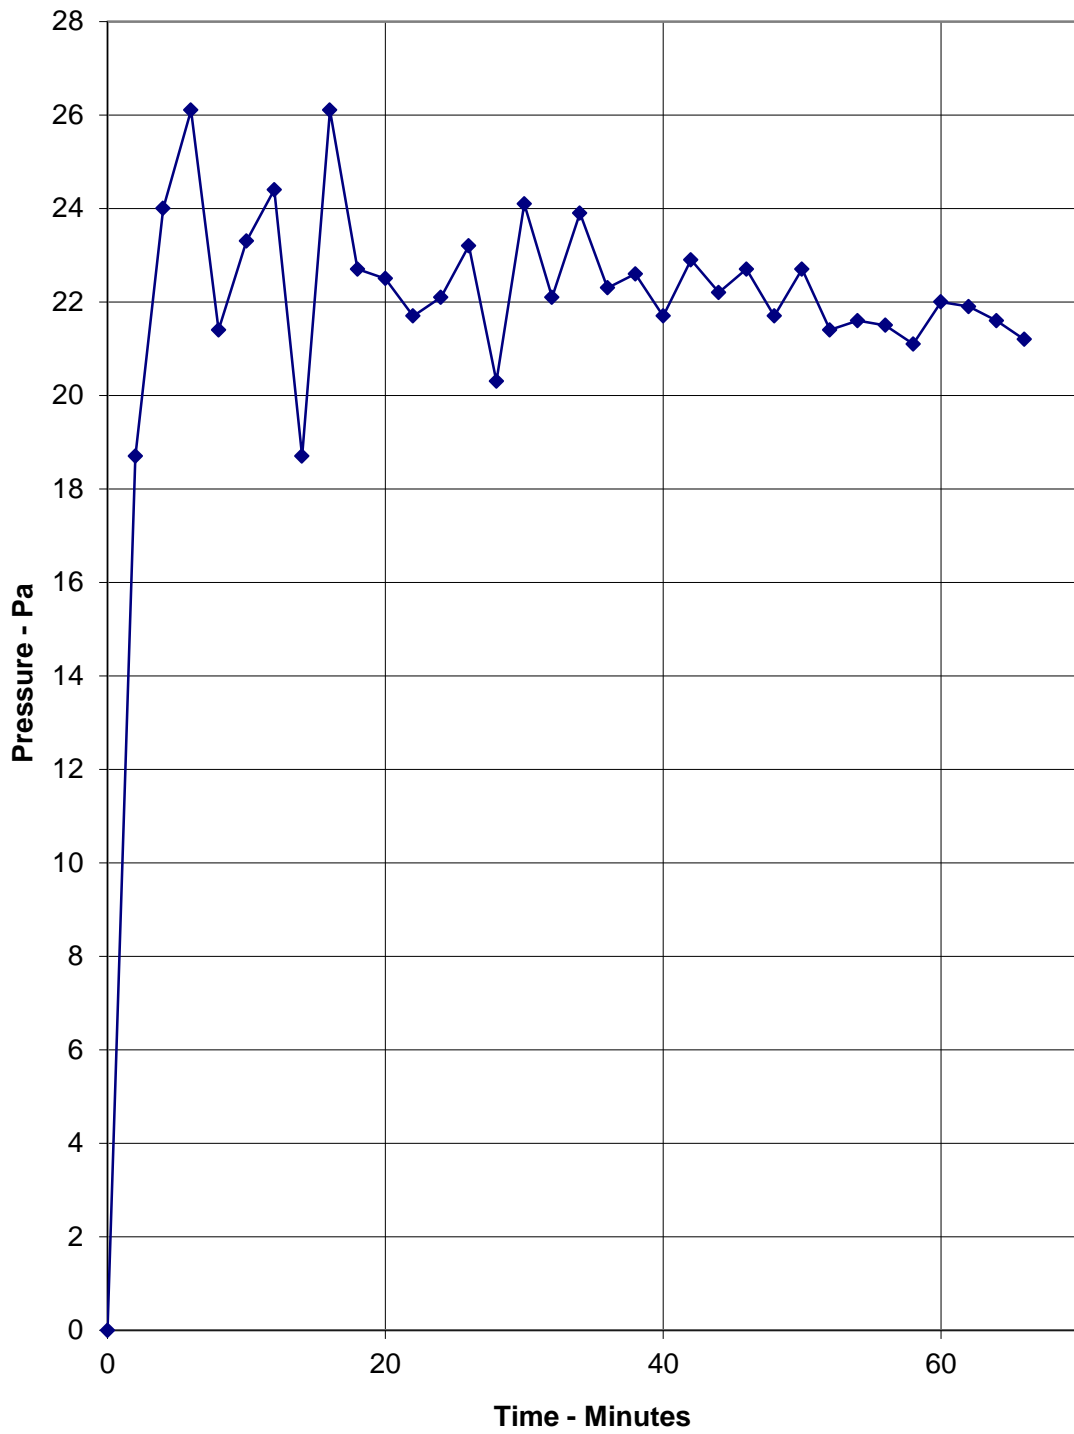
Graph showing recorded furnace pressure 100mm above head of the wall specimens
