The fire resistance performance of a partially insulated, single-acting single-leaf access door when tested generally in accordance with BS 476: Part 22: 1987, Clause 7.

185754

**Timloc Building
Products Limited**

10th November 2009

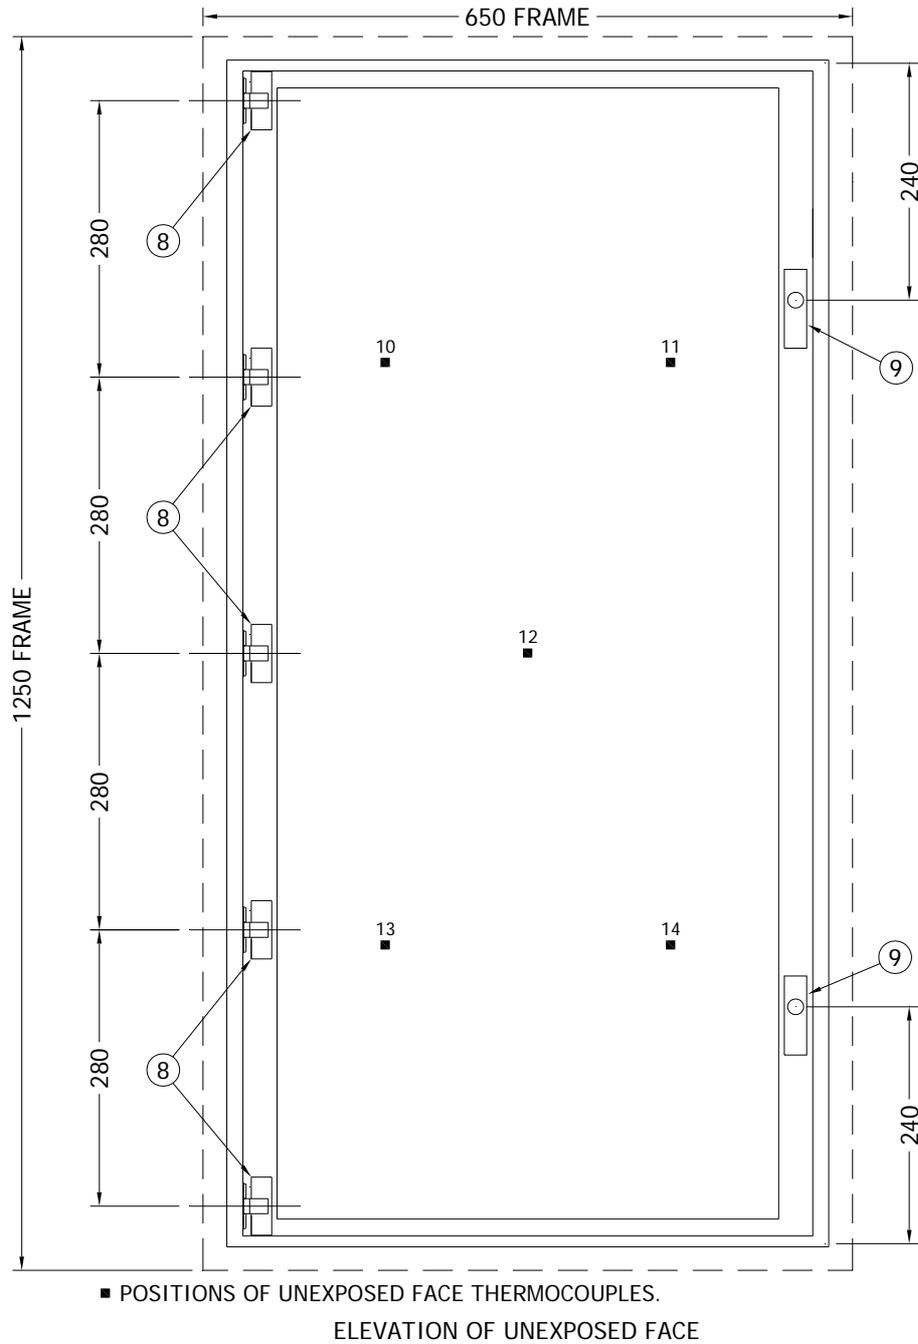
Figure 1- General elevation of the unexposed face of the specimen

| Thermocouples 10 to 14 | <p>At five positions on the unexposed surface of the doorset, one approximately at the centre and one at approximately the centre of each quarter section of the doorset.</p> <p>The locations and reference numbers of the various unexposed surface thermocouples are shown in Figure 1.</p> |

| Time | | All observations are from the unexposed face unless noted otherwise. |
|---|---|---|
| 11 | 00 | The outer layer of foil becomes detached from the left side of the head of the door leaf. The maximum temperature rise is exceeded from thermocouple number 10. Insulation failure is deemed to occur. |

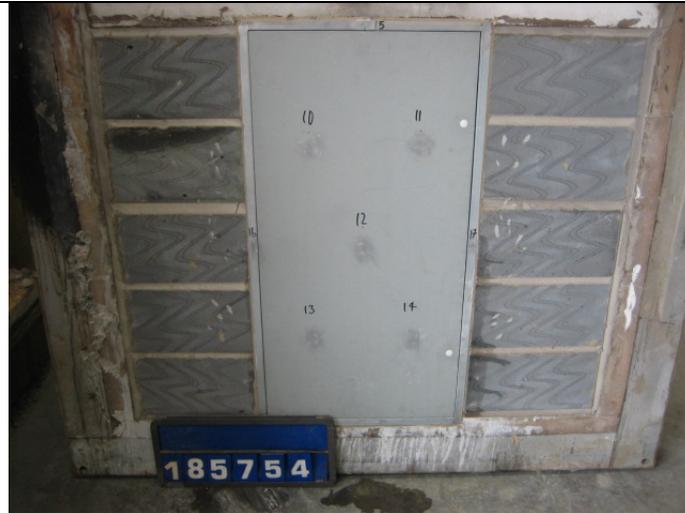
The exposed face of the specimen prior to testing

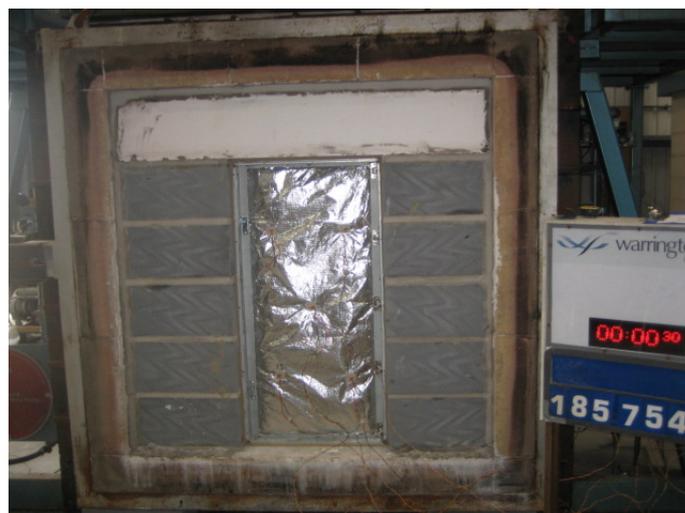
The unexposed face of the specimen prior to testing

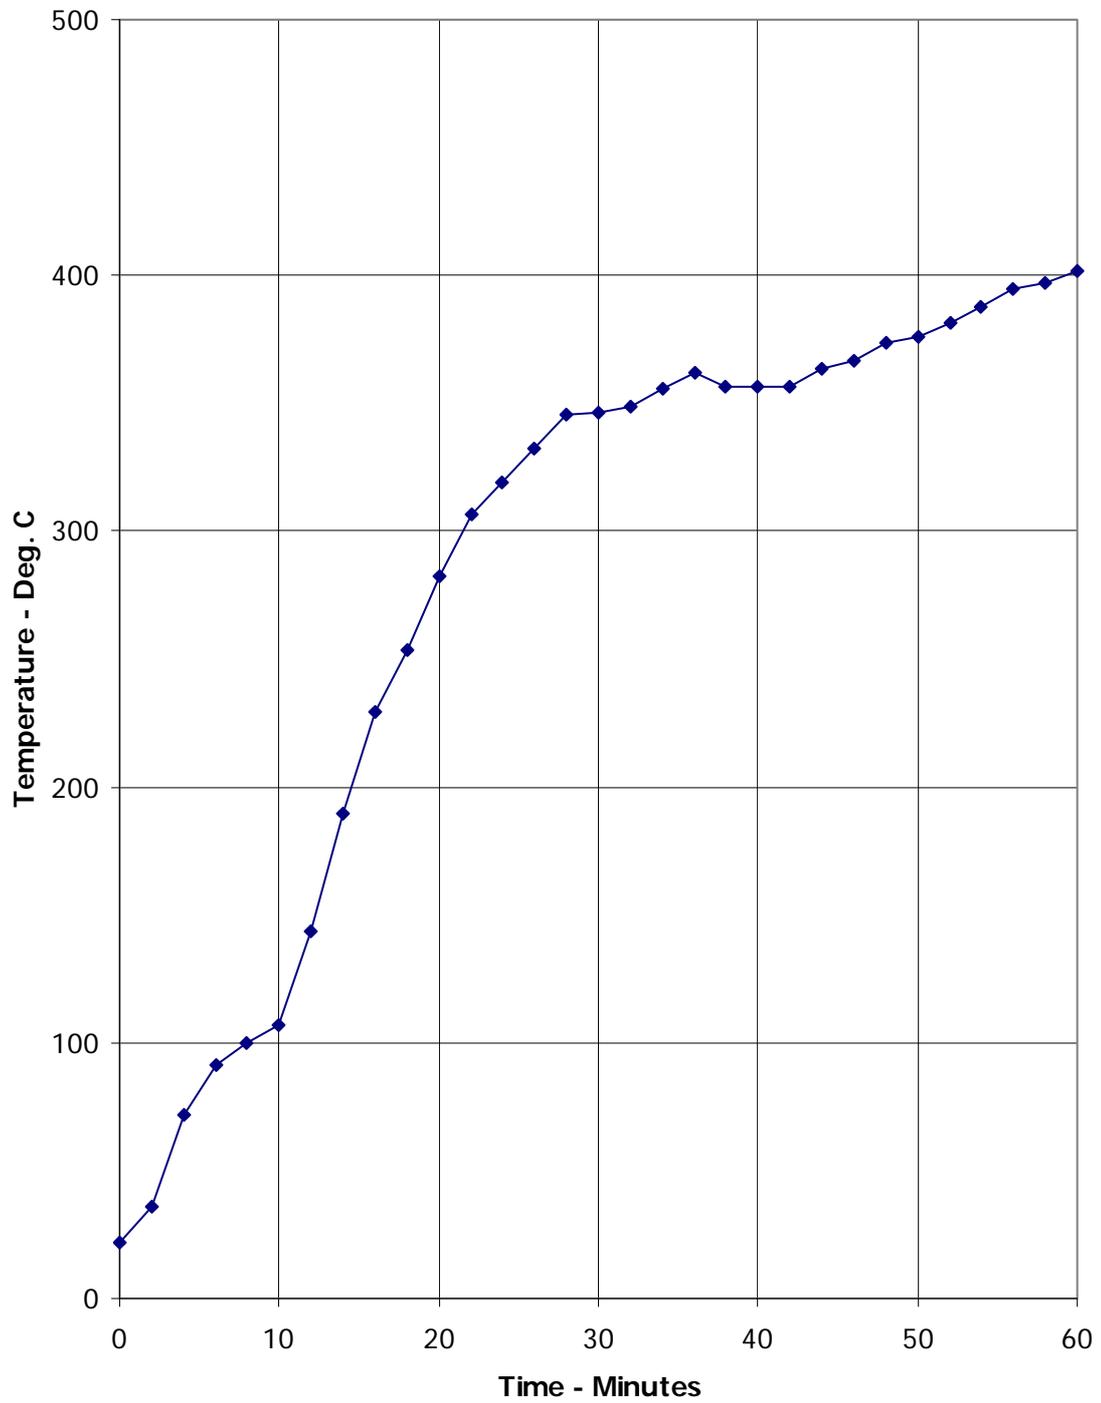
**Graph Showing Individual and Mean Temperatures Recorded
On The Unexposed Surface Of The Door Leaf**

Insulation It is required that the mean temperature rise of the unexposed surface shall not be greater than 140°C and that the maximum temperature rise shall not be greater than 180°C. Insulation failure also occurs simultaneously with integrity failure. These requirements were satisfied for a period of 11 minutes after which time the maximum temperature rise was exceeded.
